DIXON HEANEY KEAN KENNEDY

SINGLE SURVEY REPORT

59 PENDREICH GROVE BONNYRIGG MIDLOTHIAN EH19 2EH

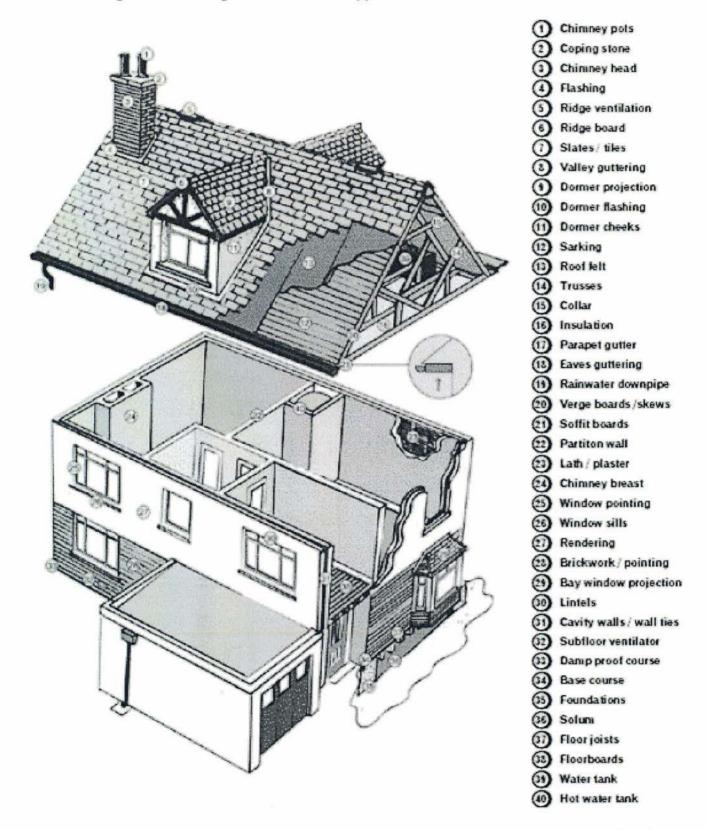
Sectional diagram showing elements of a typical house

Reference may be made in this report to some or all of the above component parts of the property. This diagram may assist you in locating and understanding these terms.
