**Shepherd Chartered Surveyors**

32 ANDERSON STREET  
DYSART  
KIRKCALDY  
KY1 2XE

# Energy Performance Certificate (EPC)

# Scottish Single Survey

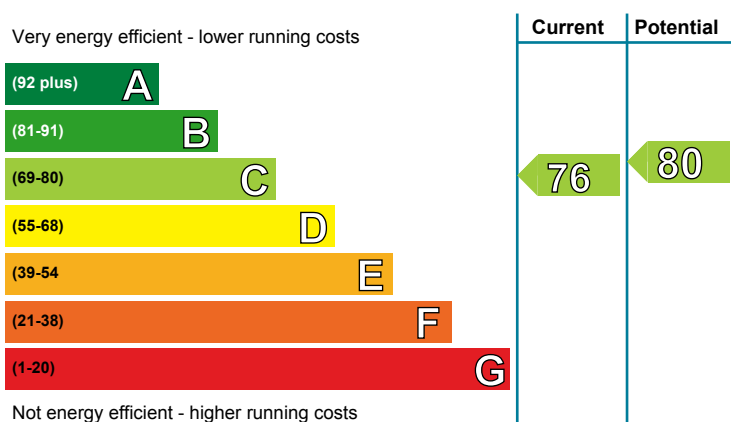
## Energy Efficiency Rating

This graph shows the current efficiency of your home, taking into account both energy efficiency and fuel costs. The higher this rating, the lower your fuel bills are likely to be.

Your current rating is **band C (76)**. The average rating for EPCs in Scotland is **band D (61)**.

The potential rating shows the effect of undertaking all of the improvement measures listed within your recommendations report.

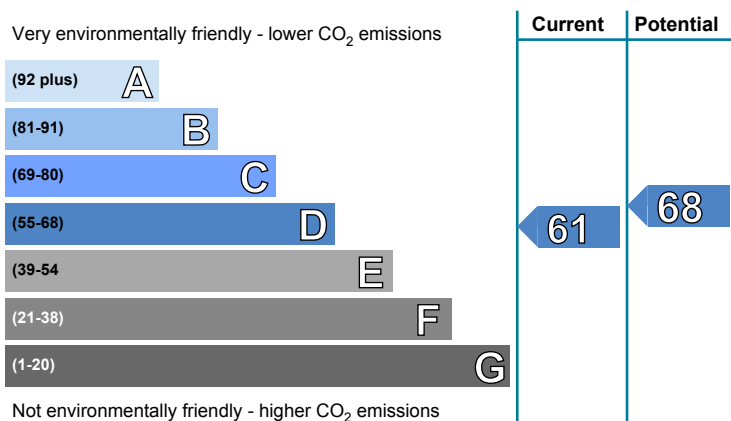
## Environmental Impact (CO<sub>2</sub>) Rating

This graph shows the effect of your home on the environment in terms of carbon dioxide (CO<sub>2</sub>) emissions. The higher the rating, the less impact it has on the environment.

Your current rating is **band D (61)**. The average rating for EPCs in Scotland is **band D (59)**.

The potential rating shows the effect of undertaking all of the improvement measures listed within your recommendations report.
