# Home Report

Flat 3, Beechlawn  
20 Culduthel Rd  
Inverness  
IV2 4AJ

# single survey

## survey report on:

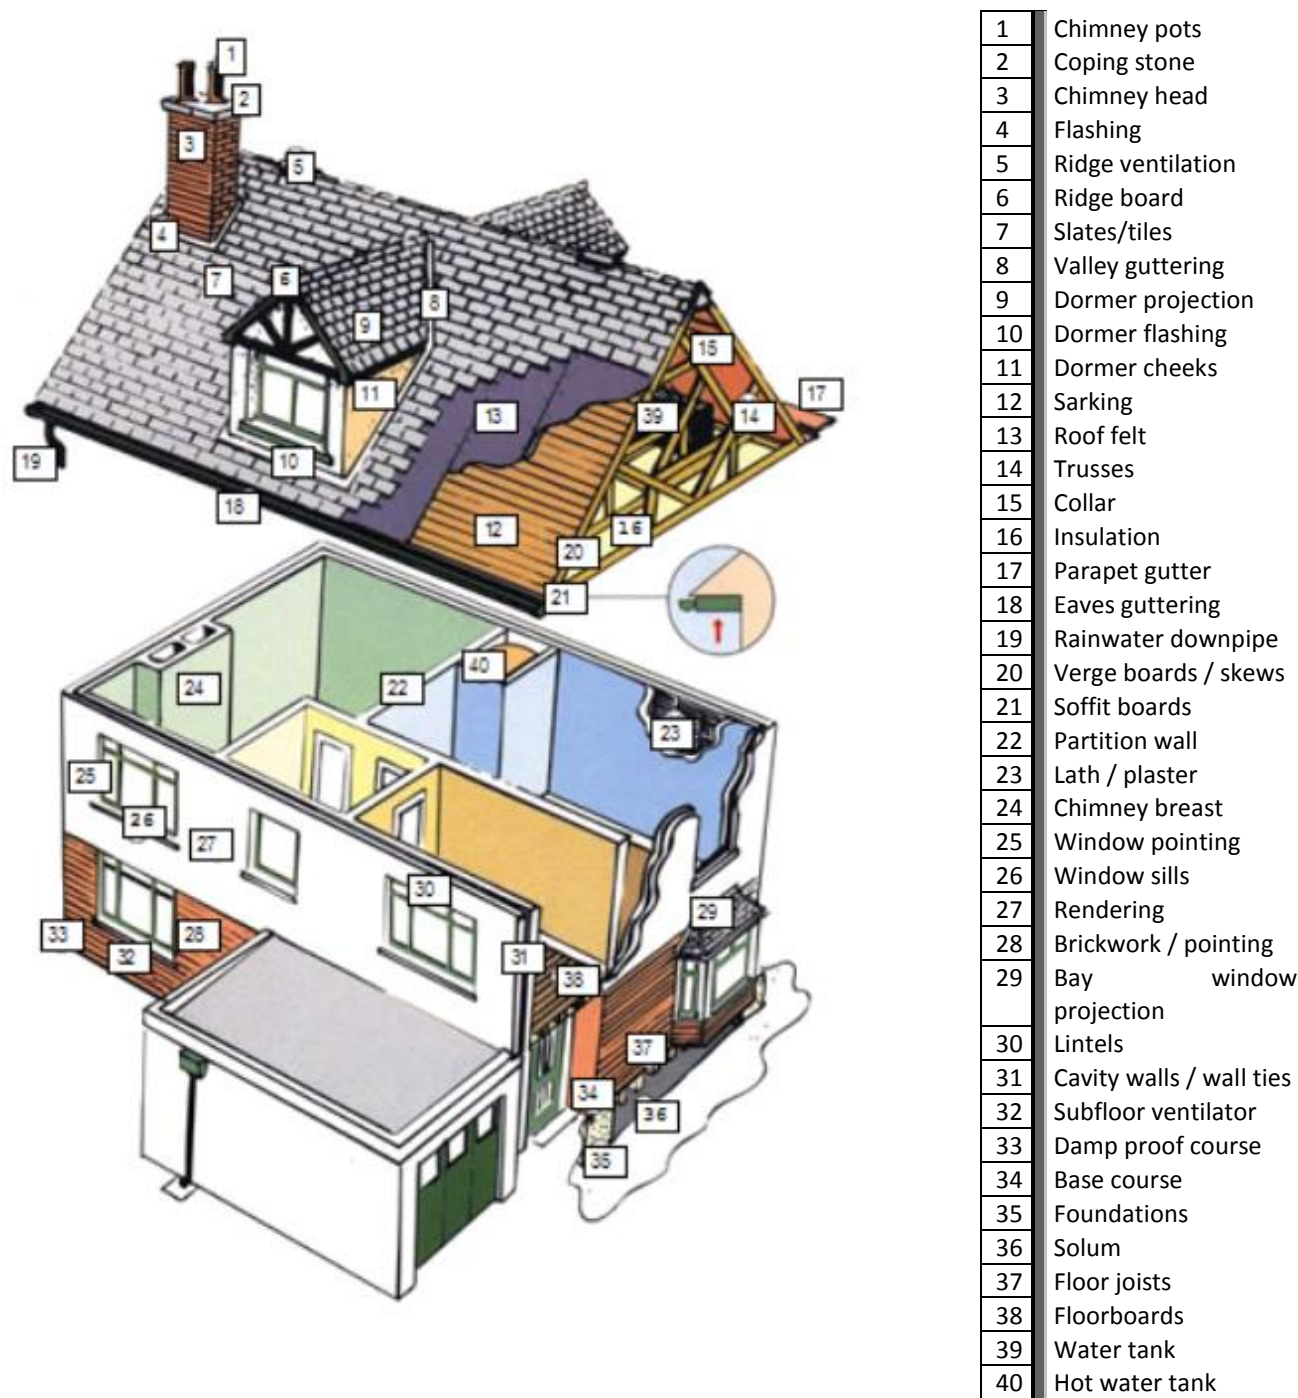
# Sectional Diagram showing elements of a typical house

Reference may be made in this report to some or all of the above component parts of the property. This diagram may assist you in locating and understanding these items.
