# Single Survey

survey report on:

| <b>Property address</b> | 153 Bonnyview Drive,<br>Aberdeen,<br>AB16 7EY |

| <b>Prepared by</b> | Harvey Donaldson And Gibson |

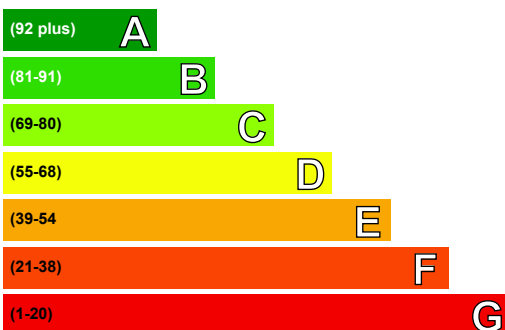
\* based upon the cost of energy for heating, hot water, lighting and ventilation, calculated using standard assumptions

Very energy efficient - lower running costs

Not energy efficient - higher running costs

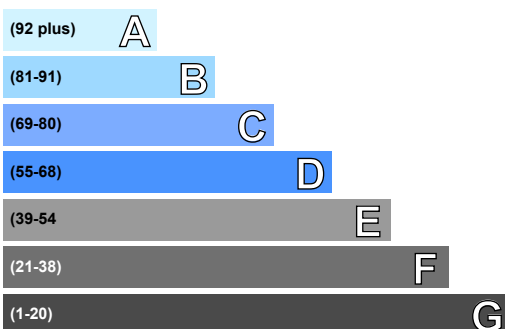
Very environmentally friendly - lower CO<sub>2</sub> emissions

Not environmentally friendly - higher CO<sub>2</sub> emissions
