HOME REPORT

5 KING STREET
BUCKIE
AB56 1SH

Energy Performance Certificate (EPC)

Single Survey

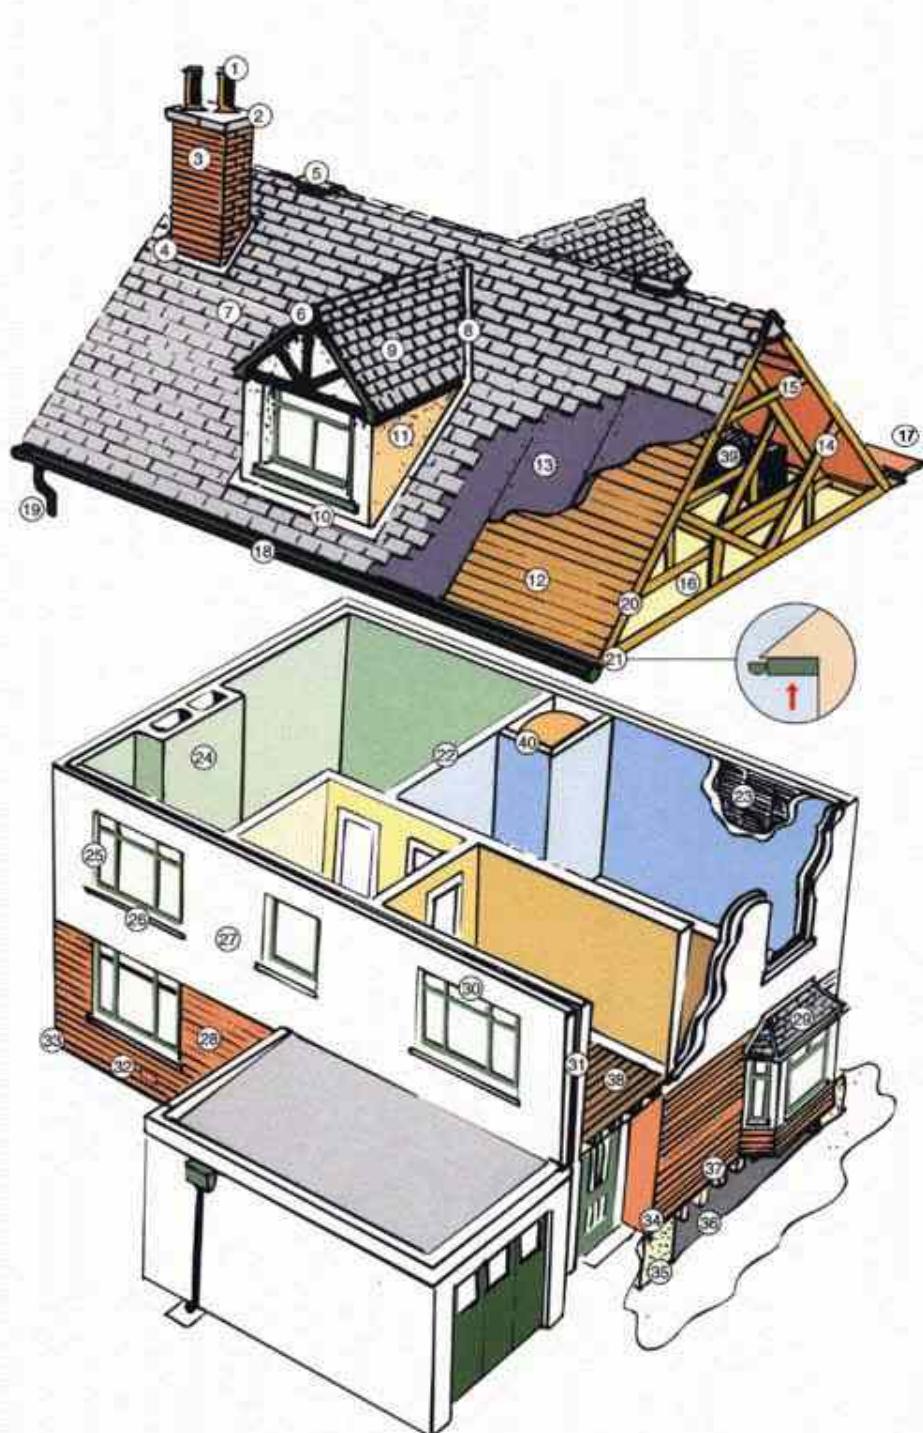
Sectional Diagram showing elements of a typical house

- 1 Chimney pots
- 2 Coping stone
- 3 Chimney head
- 4 Flashing
- 5 Ridge ventilation
- 6 Ridge board
- 7 Slates / tiles
- 8 Valley guttering
- 9 Dormer projection
- 10 Dormer flashing
- 11 Dormer cheeks
- 12 Sarking
- 13 Roof felt
- 14 Trusses
- 15 Collar
- 16 Insulation
- 17 Parapet gutter
- 18 Eaves guttering
- 19 Rainwater downpipe
- 20 Verge boards /skews
- 21 Soffit boards
- 22 Partition wall
- 23 Lath / plaster
- 24 Chimney breast
- 25 Window pointing
- 26 Window sills
- 27 Rendering
- 28 Brickwork / pointing
- 29 Bay window projection
- 30Lintels
- 31 Cavity walls / wall ties
- 32 Subfloor ventilator
- 33 Damp proof course
- 34 Base course
- 35 Foundations
- 36 Solum
- 37 Floor joists
- 38 Floorboards
- 39 Water tank
- 40 Hot water tank

Reference may be made in this report to some or all of the above component parts of the property. This diagram may assist you in locating and understanding these items.
