**Shepherd Chartered Surveyors**

200 WESTBURN ROAD  
ABERDEEN  
AB25 2LT

# Energy Performance Certificate (EPC)

# Scottish Single Survey

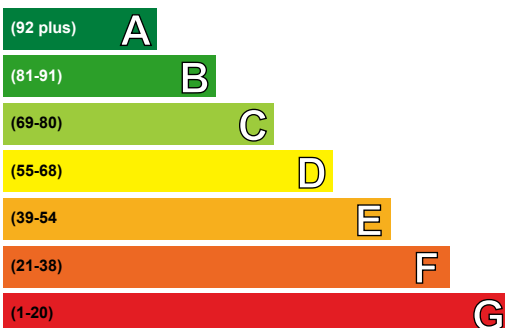
## Energy Efficiency Rating

This graph shows the current efficiency of your home, taking into account both energy efficiency and fuel costs. The higher this rating, the lower your fuel bills are likely to be.

Your current rating is **band D (64)**. The average rating for EPCs in Scotland is **band D (61)**.

The potential rating shows the effect of undertaking all of the improvement measures listed within your recommendations report.

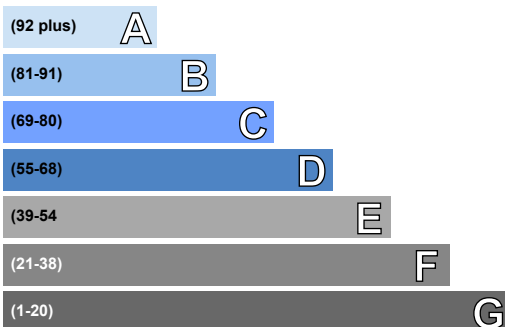
Very environmentally friendly - lower CO<sub>2</sub> emissions

Not environmentally friendly - higher CO<sub>2</sub> emissions

The potential rating shows the effect of undertaking all of the improvement measures listed within your recommendations report.
