# HOME REPORT

# Energy Performance Certificate (EPC)

**NORTH STEADING PITSKELLY, FORDOUN, LAURENCEKIRK, AB30 1LB**

**Dwelling type:** End-terrace bungalow  
**Date of assessment:** 17 April 2019  
**Date of certificate:** 23 April 2019  
**Total floor area:** 142 m<sup>2</sup>  
**Primary Energy Indicator:** 193 kWh/m<sup>2</sup>/year

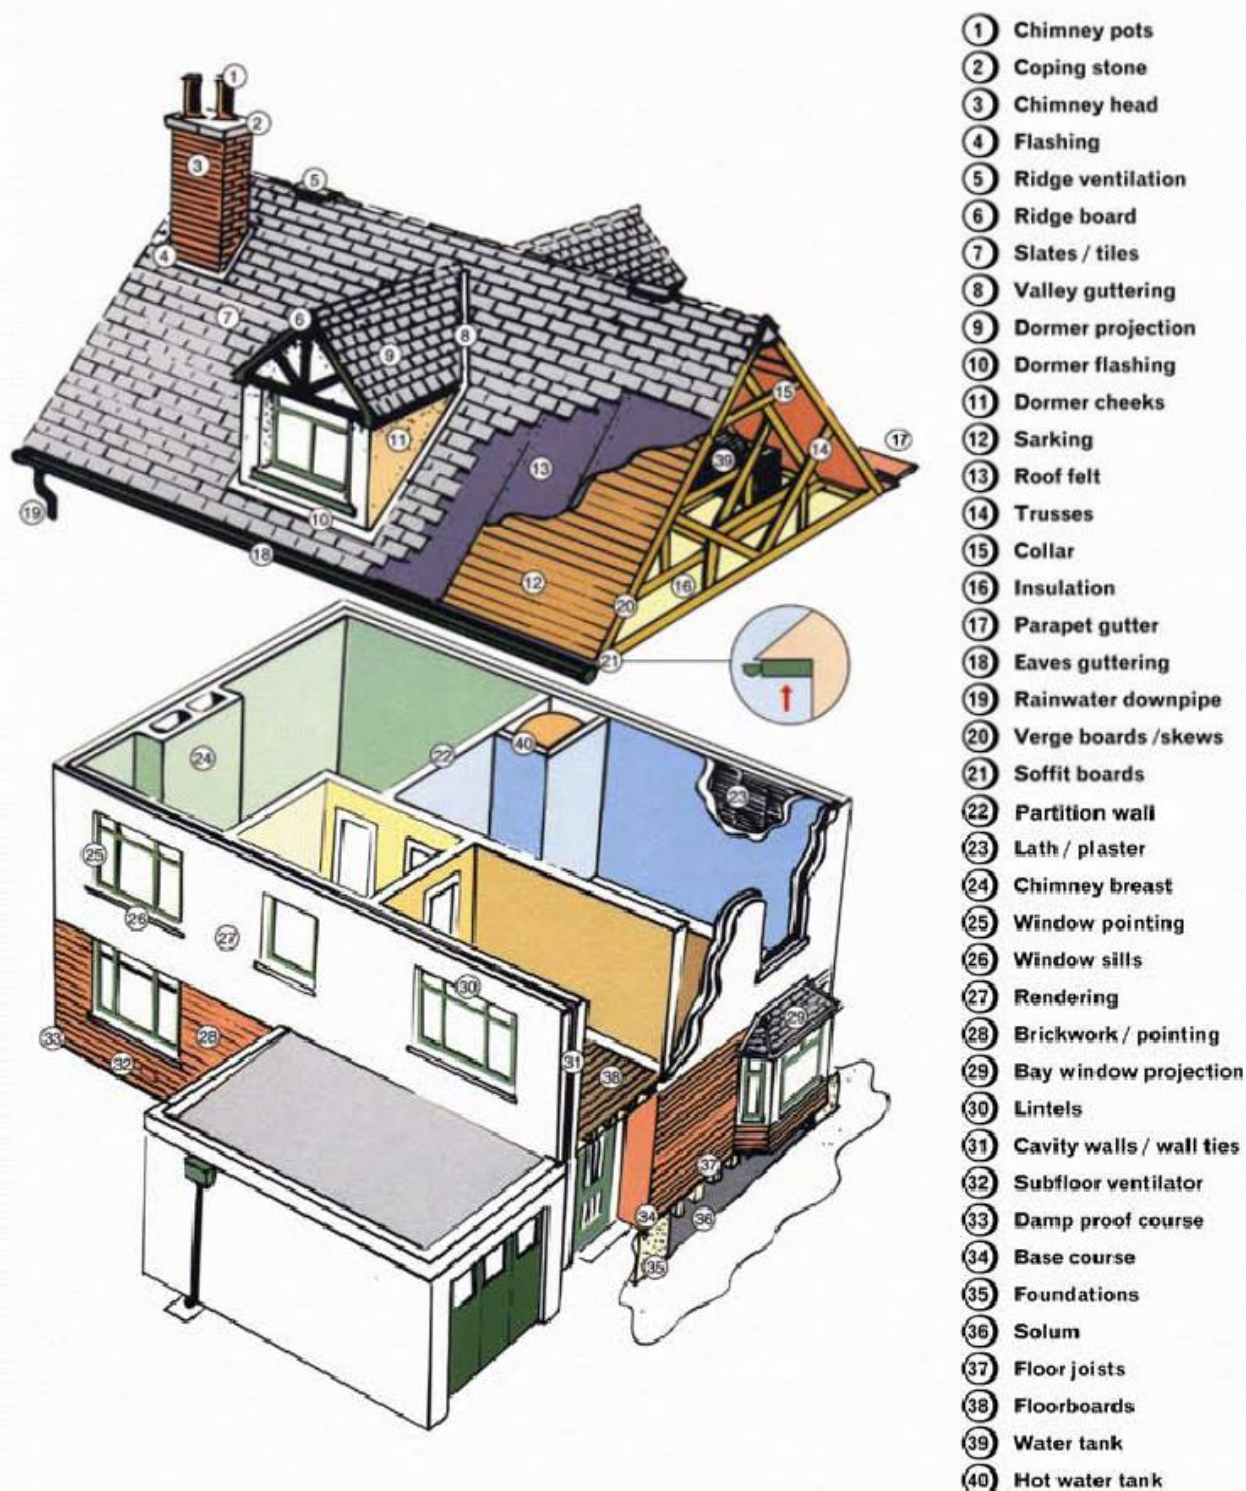
## Sectional Diagram showing elements of a typical house

Reference may be made in this report to some or all of the above component parts of the property. This diagram may assist you in locating and understanding these items.
