**HOME REPORT**

66 KIRKLANDS PARK  
CUPAR  
KY15 4EP

# Energy Performance Certificate (EPC)

# Single Survey

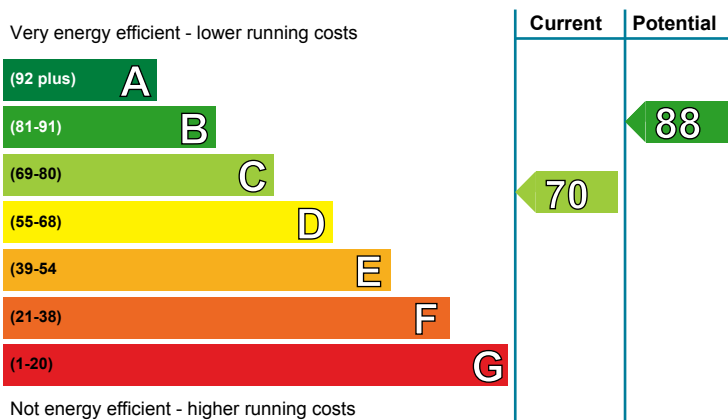
## Energy Efficiency Rating

This graph shows the current efficiency of your home, taking into account both energy efficiency and fuel costs. The higher this rating, the lower your fuel bills are likely to be.

Your current rating is **band C (70)**. The average rating for EPCs in Scotland is **band D (61)**.

The potential rating shows the effect of undertaking all of the improvement measures listed within your recommendations report.
