# HOME REPORT

# Energy Performance Certificate (EPC)

21 COTTON STREET, BALFRON, GLASGOW, G63 0PE

**Dwelling type:** Semi-detached house  
**Date of assessment:** 09 August 2019  
**Date of certificate:** 17 August 2019  
**Total floor area:** 107 m<sup>2</sup>  
**Primary Energy Indicator:** 330 kWh/m<sup>2</sup>/year

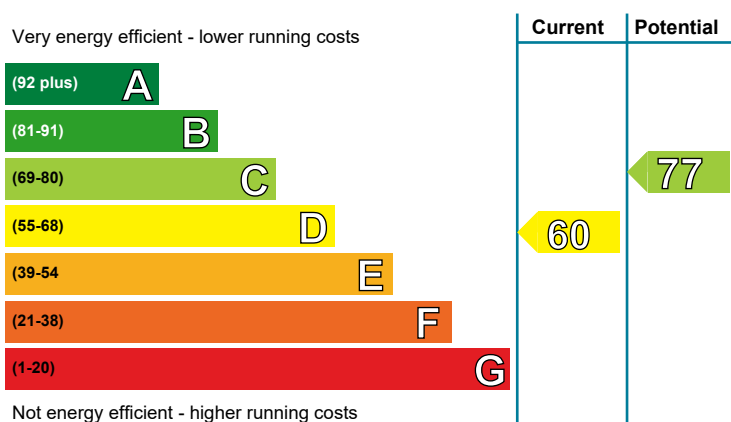
## Energy Efficiency Rating

This graph shows the current efficiency of your home, taking into account both energy efficiency and fuel costs. The higher this rating, the lower your fuel bills are likely to be.

Your current rating is **band D (60)**. The average rating for EPCs in Scotland is **band D (61)**.

The potential rating shows the effect of undertaking all of the improvement measures listed within your recommendations report.

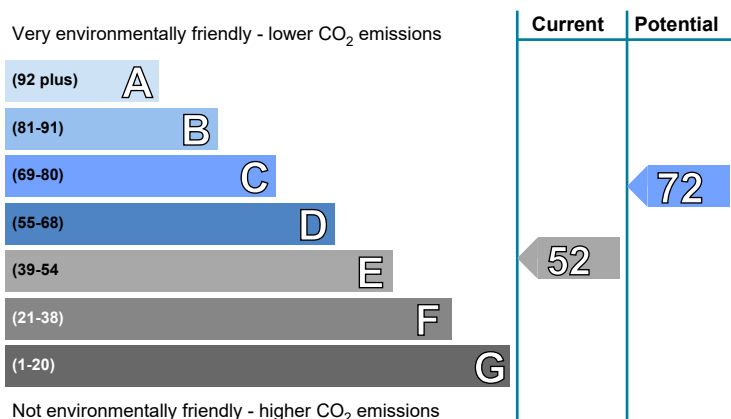
## Environmental Impact (CO<sub>2</sub>) Rating

This graph shows the effect of your home on the environment in terms of carbon dioxide (CO<sub>2</sub>) emissions. The higher the rating, the less impact it has on the environment.

The potential rating shows the effect of undertaking all of the improvement measures listed within your recommendations report.

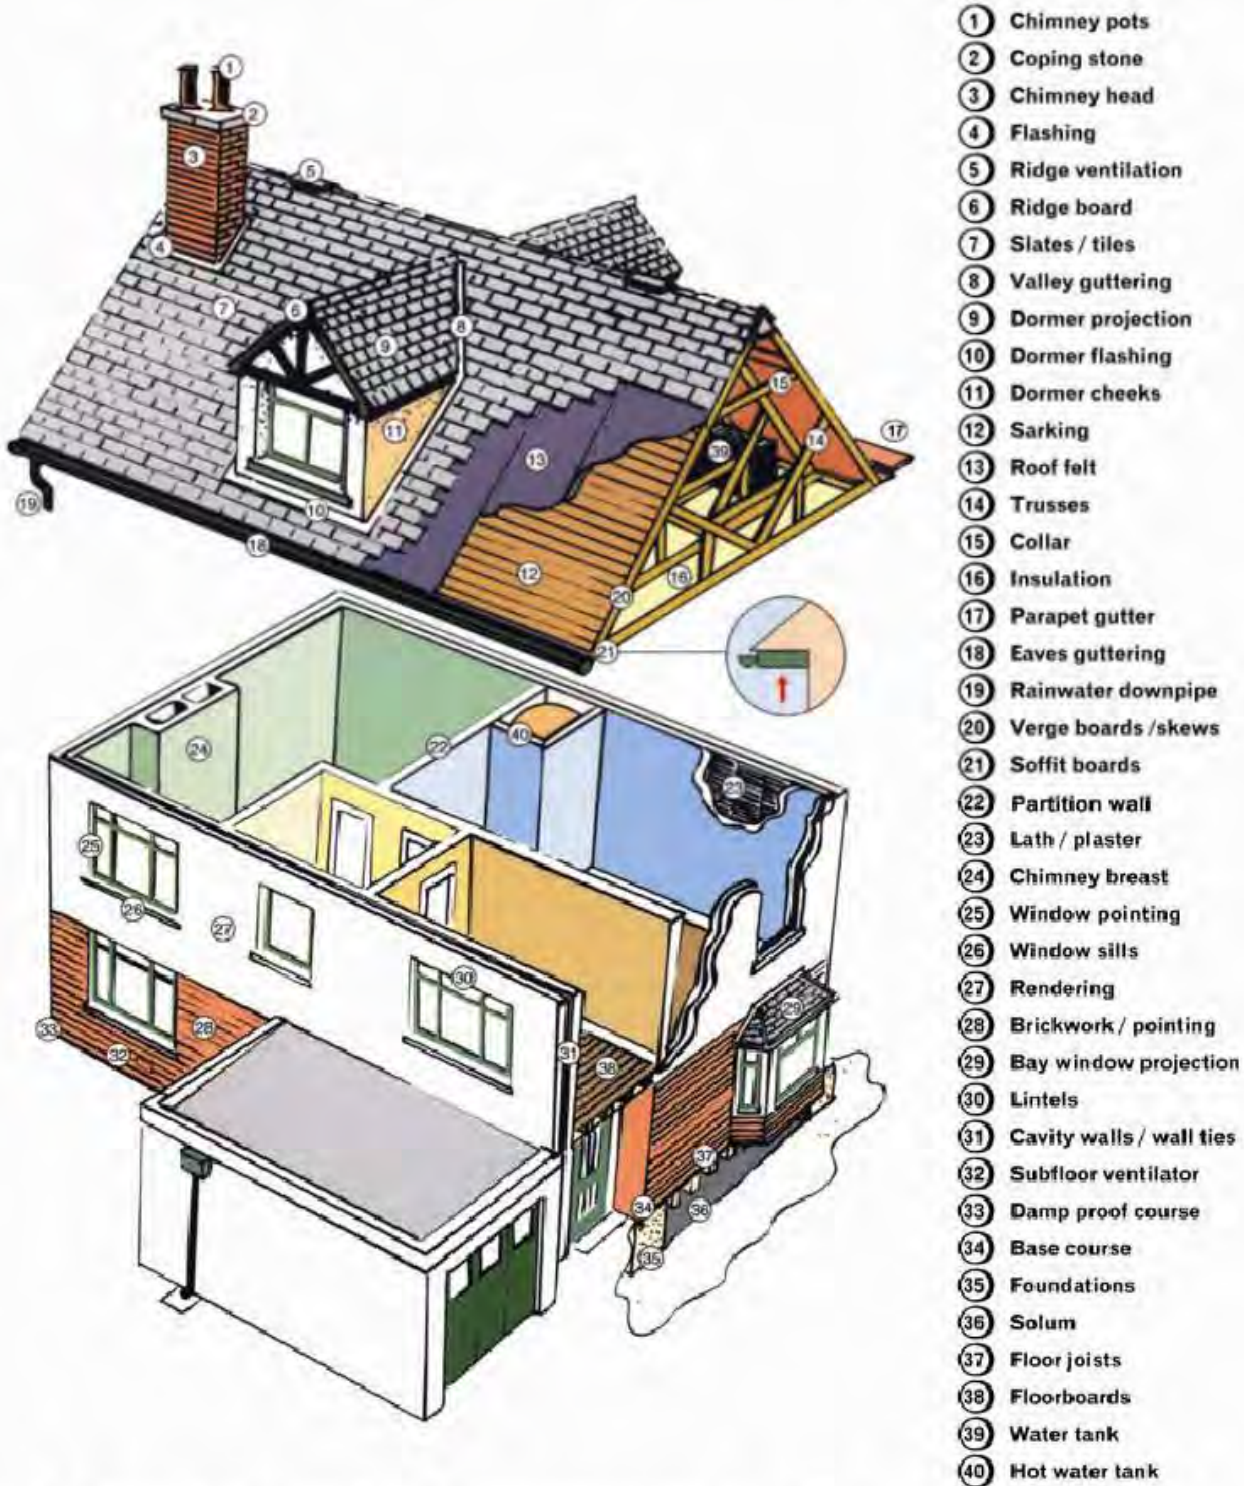
## Sectional Diagram showing elements of a typical house

Reference may be made in this report to some or all of the above component parts of the property. This diagram may assist you in locating and understanding these items.
