# HOME REPORT

VINNEY COTTAGE  
30 GOWAN STREET  
ARBROATH  
DD11 2BH

# ENERGY PERFORMANCE CERTIFICATE

# SINGLE SURVEY

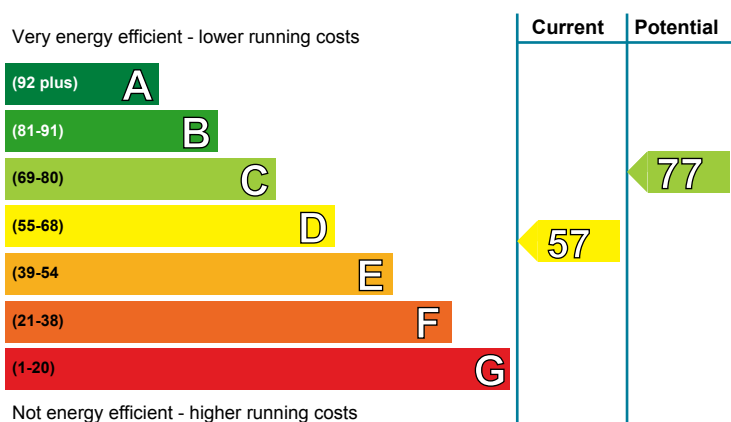
## Energy Efficiency Rating

This graph shows the current efficiency of your home, taking into account both energy efficiency and fuel costs. The higher this rating, the lower your fuel bills are likely to be.

Your current rating is **band D (57)**. The average rating for EPCs in Scotland is **band D (61)**.

The potential rating shows the effect of undertaking all of the improvement measures listed within your recommendations report.

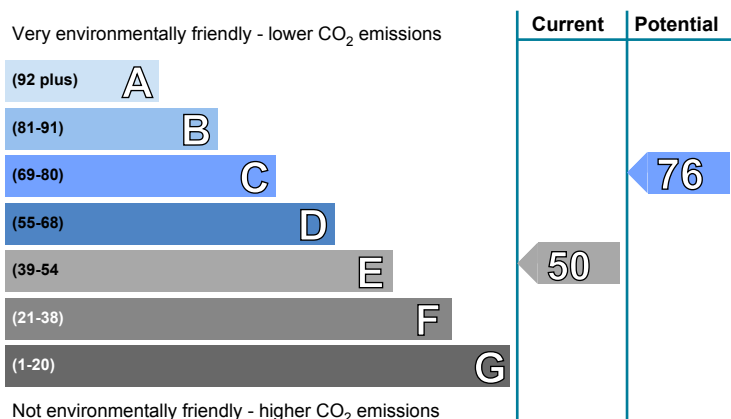
## Environmental Impact (CO<sub>2</sub>) Rating

This graph shows the effect of your home on the environment in terms of carbon dioxide (CO<sub>2</sub>) emissions. The higher the rating, the less impact it has on the environment.

Your current rating is **band E (50)**. The average rating for EPCs in Scotland is **band D (59)**.

The potential rating shows the effect of undertaking all of the improvement measures listed within your recommendations report.
