CHERLOR MOSSCASTLE ROAD

# Home Report

# Energy Performance Certificate

# Scottish Single Survey

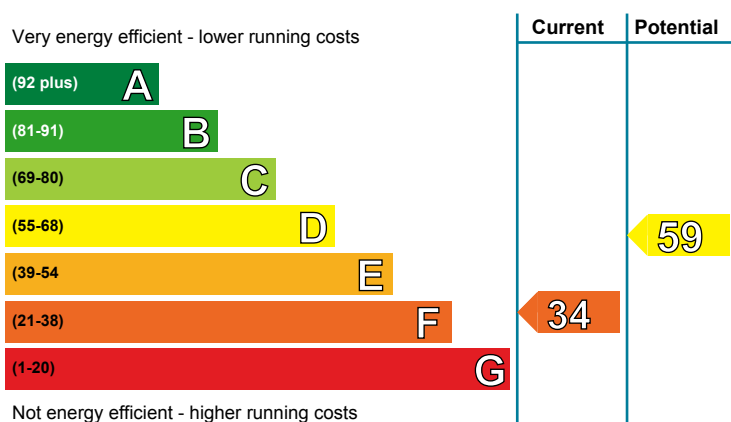
## Energy Efficiency Rating

This graph shows the current efficiency of your home, taking into account both energy efficiency and fuel costs. The higher this rating, the lower your fuel bills are likely to be.

Your current rating is **band F (34)**. The average rating for EPCs in Scotland is **band D (61)**.

The potential rating shows the effect of undertaking all of the improvement measures listed within your recommendations report.

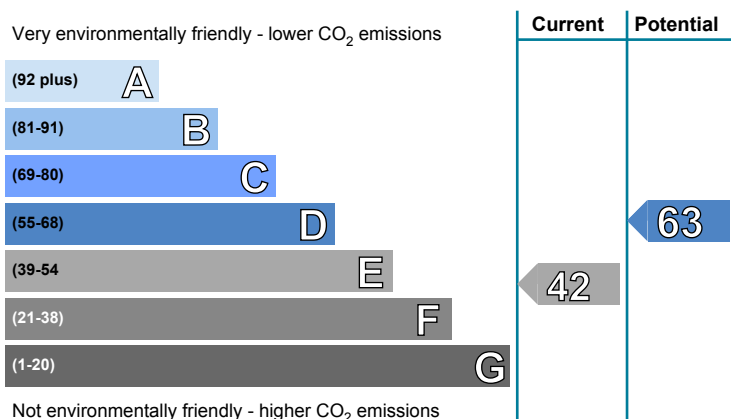
## Environmental Impact (CO<sub>2</sub>) Rating

This graph shows the effect of your home on the environment in terms of carbon dioxide (CO<sub>2</sub>) emissions. The higher the rating, the less impact it has on the environment.

The potential rating shows the effect of undertaking all of the improvement measures listed within your recommendations report.
