# Single Survey

| Property address | BASEMENT<br>71 UNION GROVE<br>ABERDEEN<br>AB10 6SJ |
| Prepared by | DM Hall LLP |
| Date of inspection | 11th April 2019 |

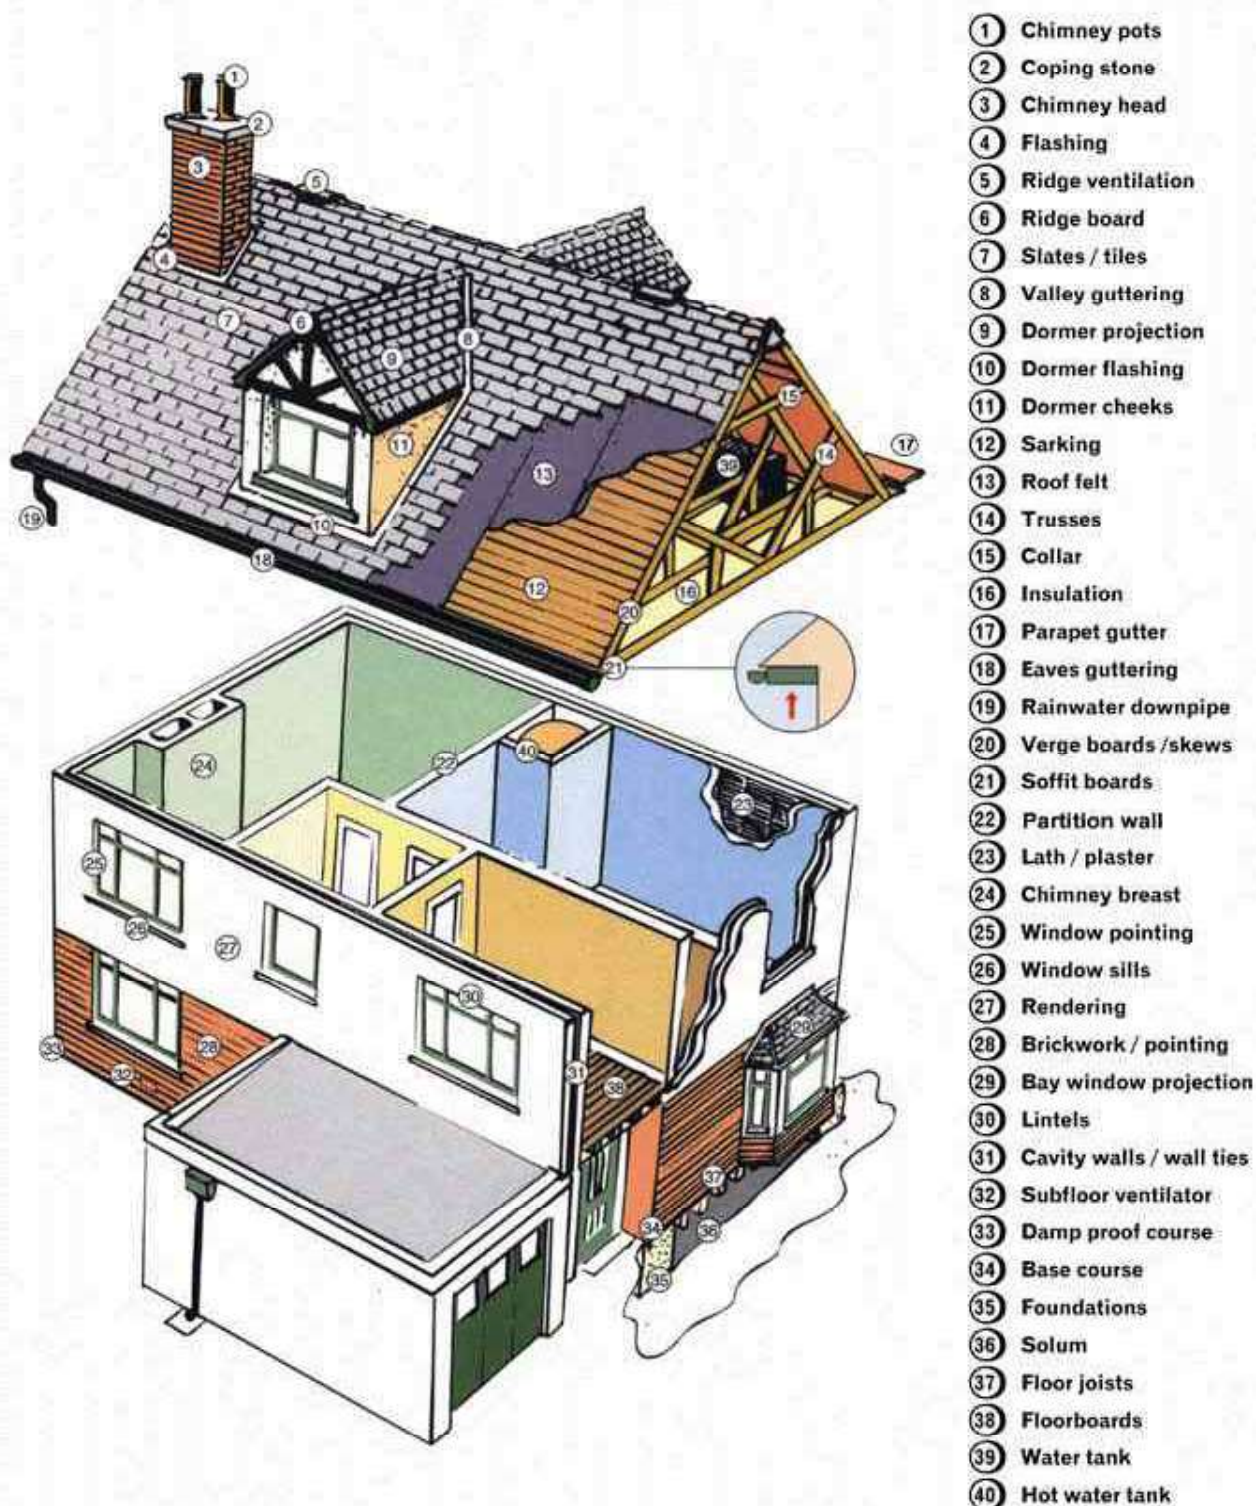
## Sectional Diagram showing elements of a typical house

Reference may be made in this report to some or all of the above component parts of the property. This diagram may assist you in locating and understanding these items.
