8 MOSSVALE  
LOCHMABEN  
LOCKERBIE  
DG11 1QB

# Home Report

8 MOSSVALE, LOCHMABEN, LOCKERBIE, DG11 1QB

# Scottish Single Survey

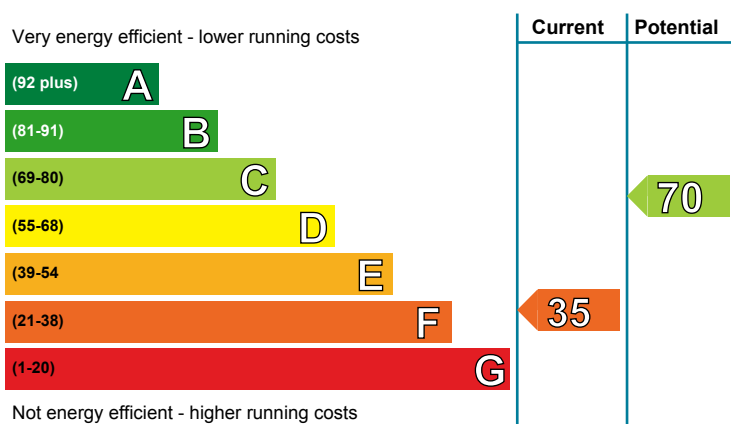
## Energy Efficiency Rating

This graph shows the current efficiency of your home, taking into account both energy efficiency and fuel costs. The higher this rating, the lower your fuel bills are likely to be.

Your current rating is **band F (35)**. The average rating for EPCs in Scotland is **band D (61)**.

The potential rating shows the effect of undertaking all of the improvement measures listed within your recommendations report.

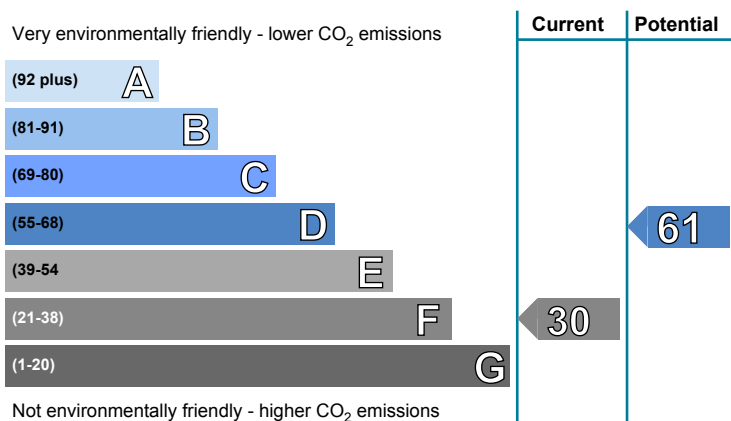
## Environmental Impact (CO<sub>2</sub>) Rating

This graph shows the effect of your home on the environment in terms of carbon dioxide (CO<sub>2</sub>) emissions. The higher the rating, the less impact it has on the environment.

Your current rating is **band F (30)**. The average rating for EPCs in Scotland is **band D (59)**.

The potential rating shows the effect of undertaking all of the improvement measures listed within your recommendations report.
