# Home Report

Property: **2/2  
2 Balmartin Road  
Glasgow  
Lanarkshire  
G23 5DZ**

Report reference: **786665-1-2**

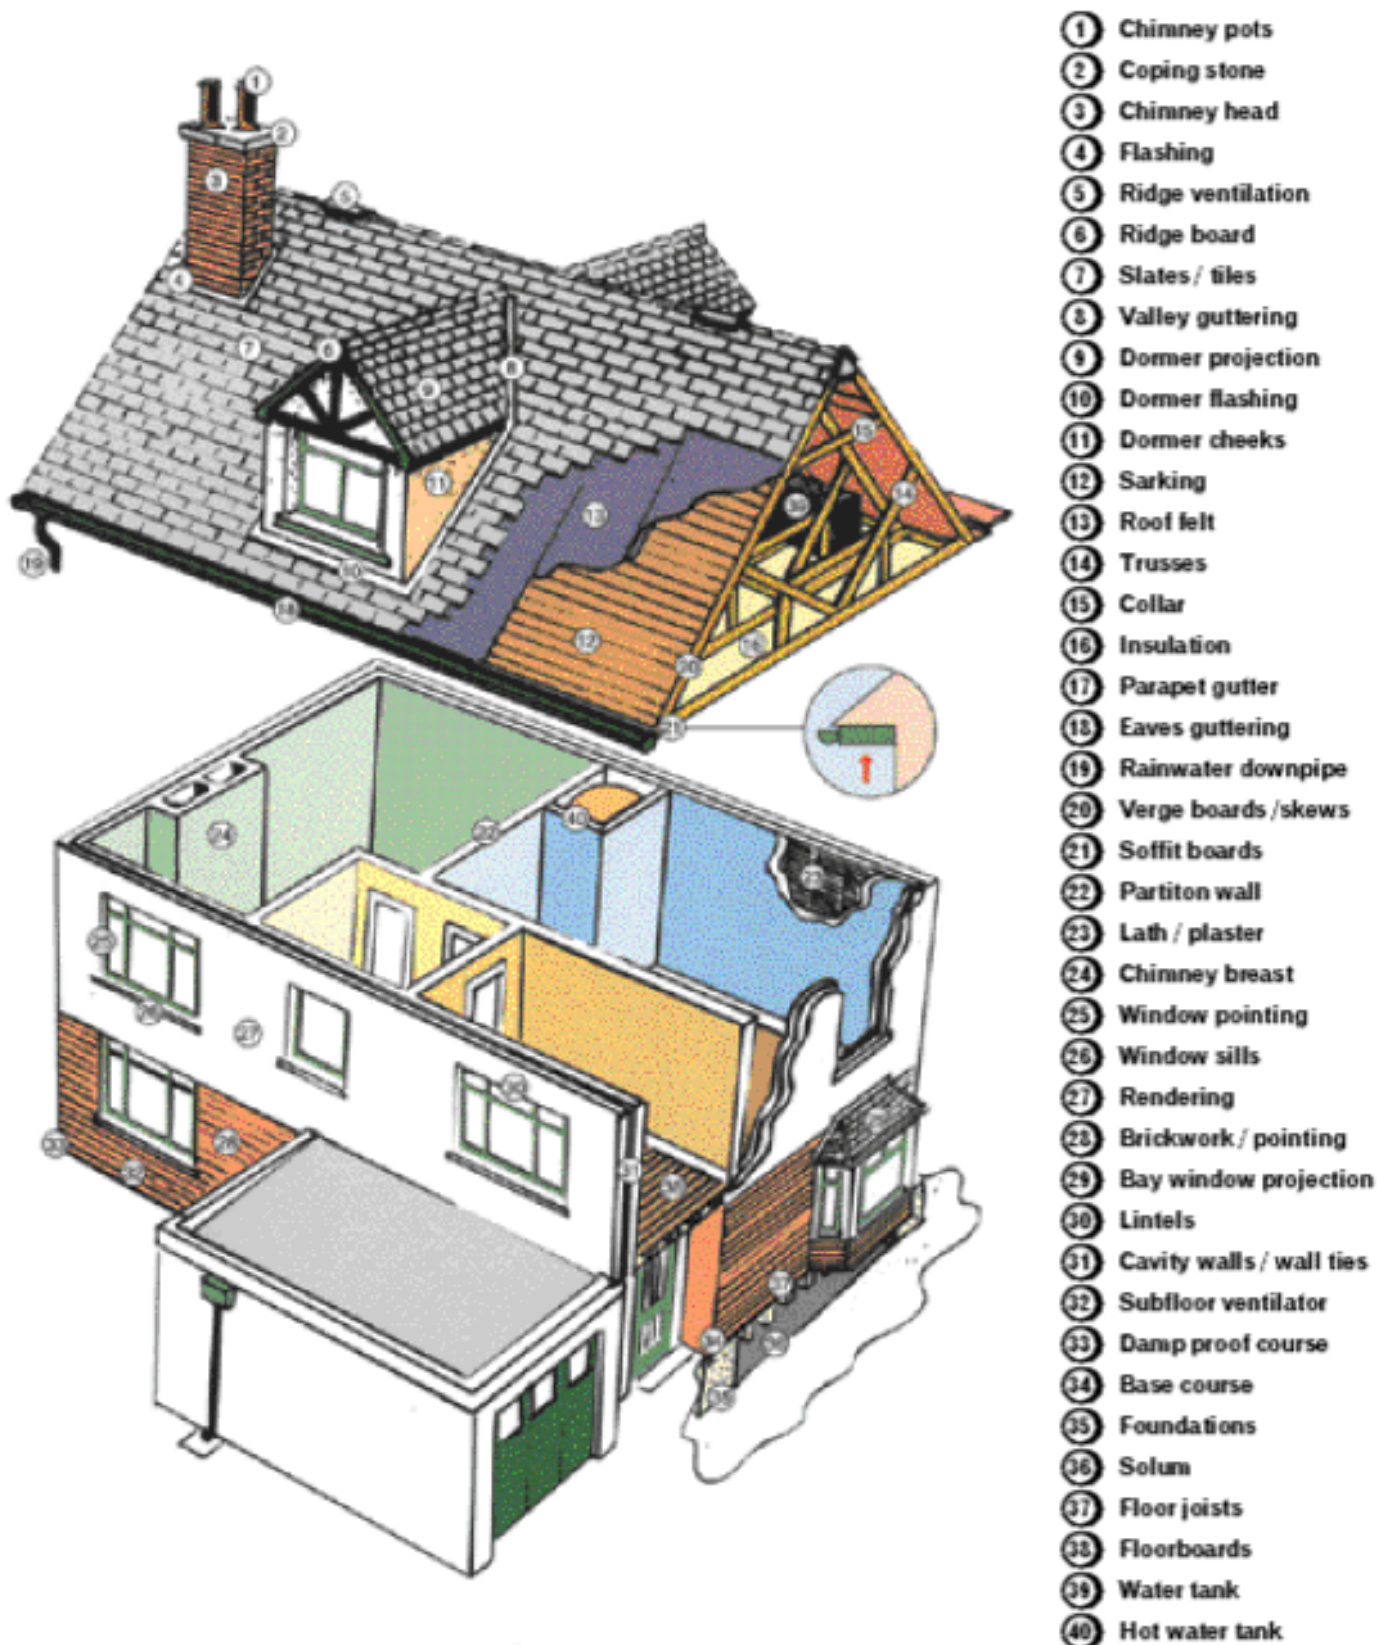
▷ Sectional diagram showing elements of a typical house:

Reference may be made in this report to some or all of the above component parts of the property. This diagram may assist you in locating and understanding these terms.
