# Home Report

Property: **1 Gairs Buildings  
Lairg Road  
Ardgay  
Highland  
IV24 3EA**

Prepared by: **Douglas Gordon BSc (Hons) MRICS**

# Energy Performance Certificate (EPC)

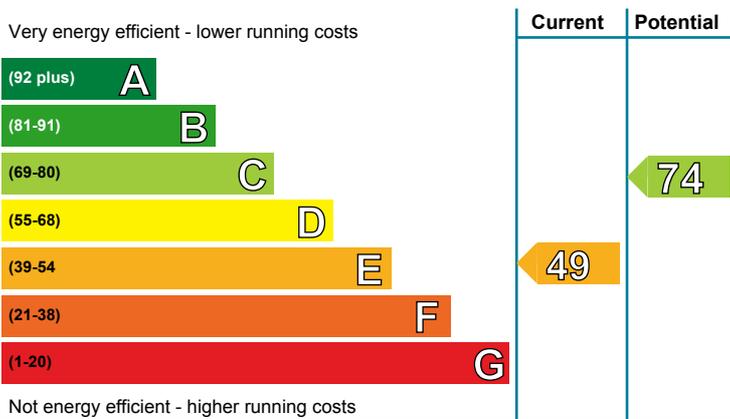
## Energy Efficiency Rating

This graph shows the current efficiency of your home, taking into account both energy efficiency and fuel costs. The higher this rating, the lower your fuel bills are likely to be.

Your current rating is **band E (49)**. The average rating for EPCs in Scotland is **band D (61)**.

The potential rating shows the effect of undertaking all of the improvement measures listed within your recommendations report.

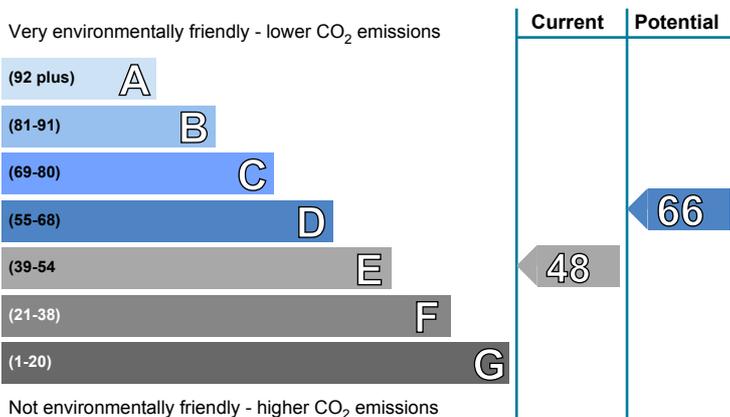
## Environmental Impact (CO<sub>2</sub>) Rating

This graph shows the effect of your home on the environment in terms of carbon dioxide (CO<sub>2</sub>) emissions. The higher the rating, the less impact it has on the environment.

Your current rating is **band E (48)**. The average rating for EPCs in Scotland is **band D (59)**.

The potential rating shows the effect of undertaking all of the improvement measures listed within your recommendations report.
