# HOME REPORT

Property: **50  
King Street  
Hamilton  
Lanarkshire  
ML3 9JH**

Report reference: **804146-1-2**

# Energy Performance Certificate (EPC)

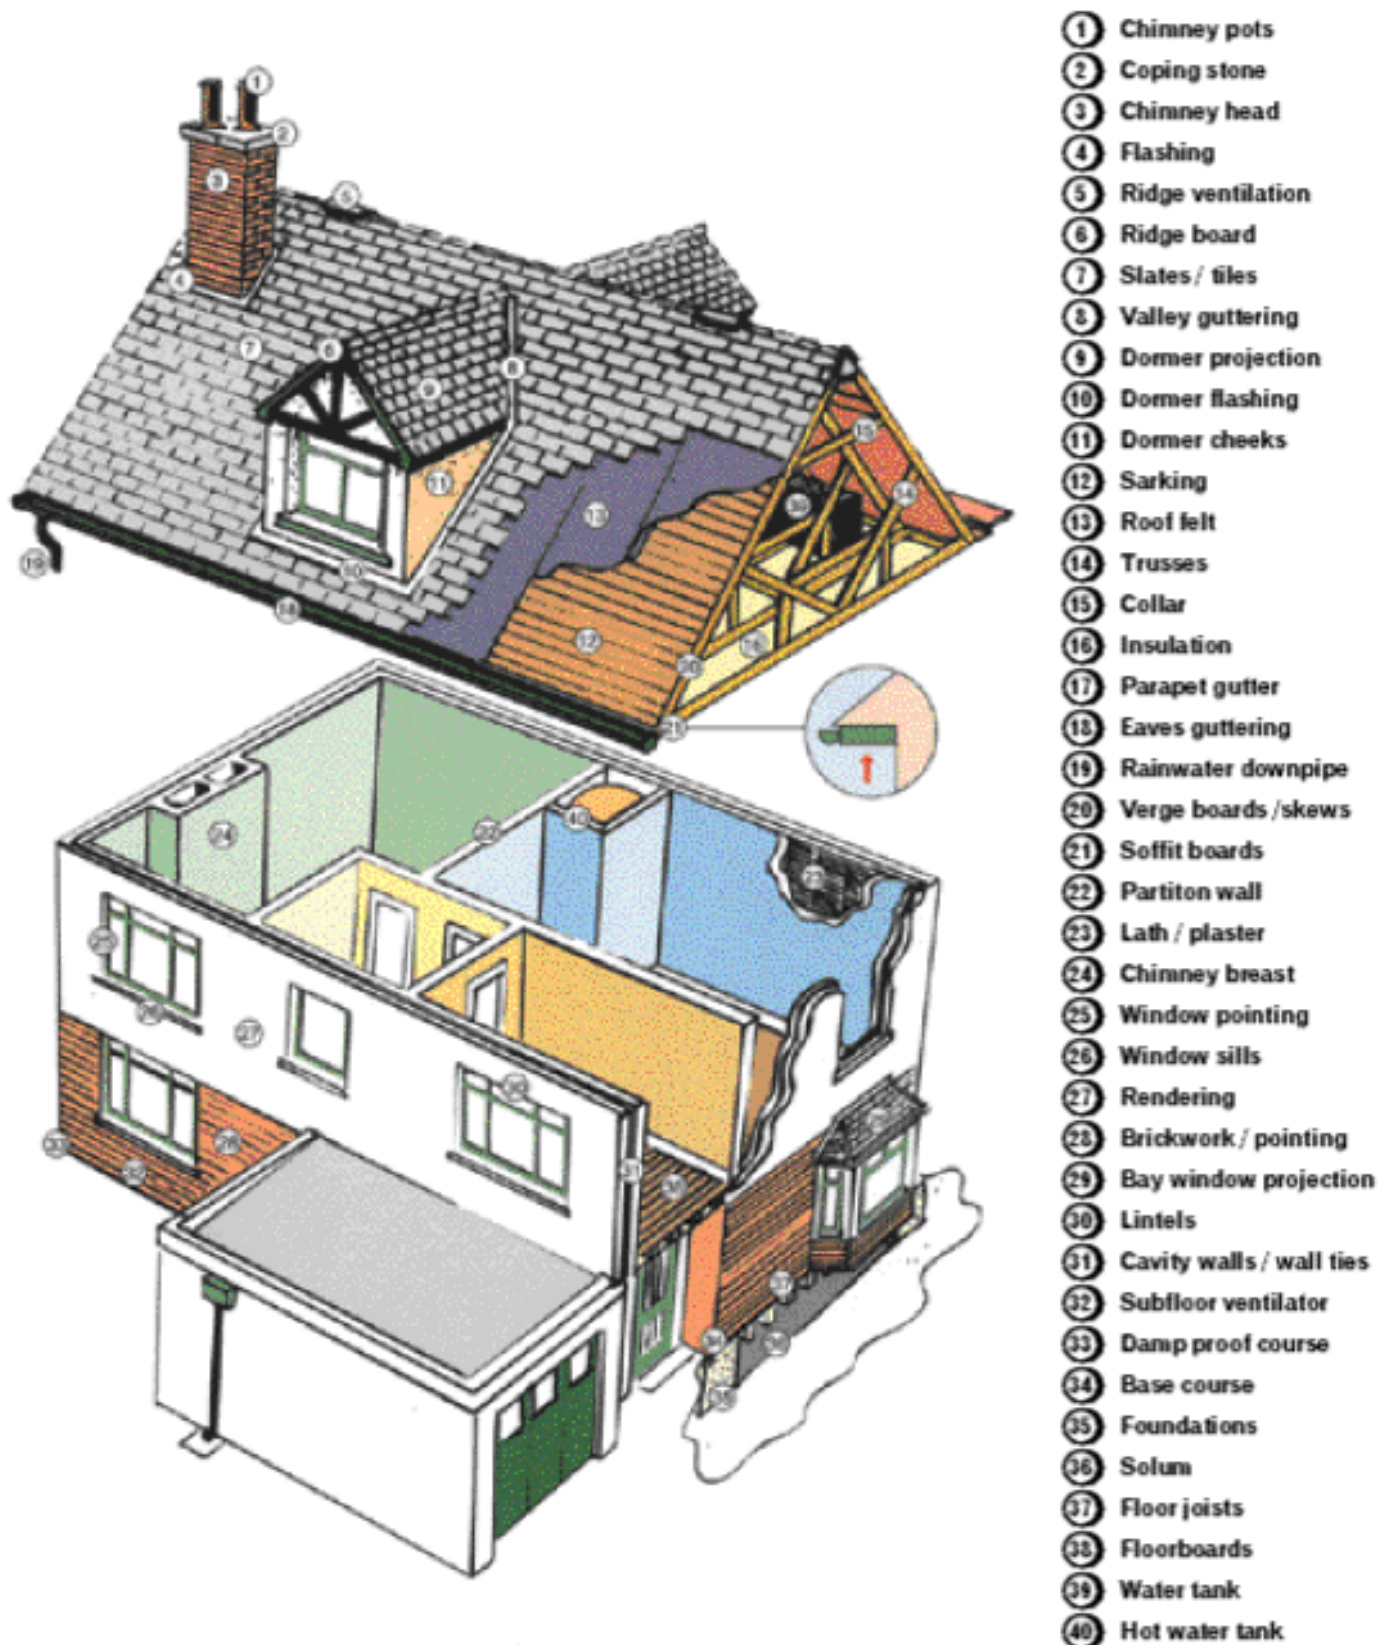
▷ Sectional diagram showing elements of a typical house:

Reference may be made in this report to some or all of the above component parts of the property. This diagram may assist you in locating and understanding these terms.
