# Single Survey

| <b>Property address</b> | 3F Herald Way,<br>Renfrew,<br>PA4 0LR |

| <b>Prepared by</b> | Harvey Donaldson And Gibson |

| <b>Date of inspection</b> | 2nd July 2020 |

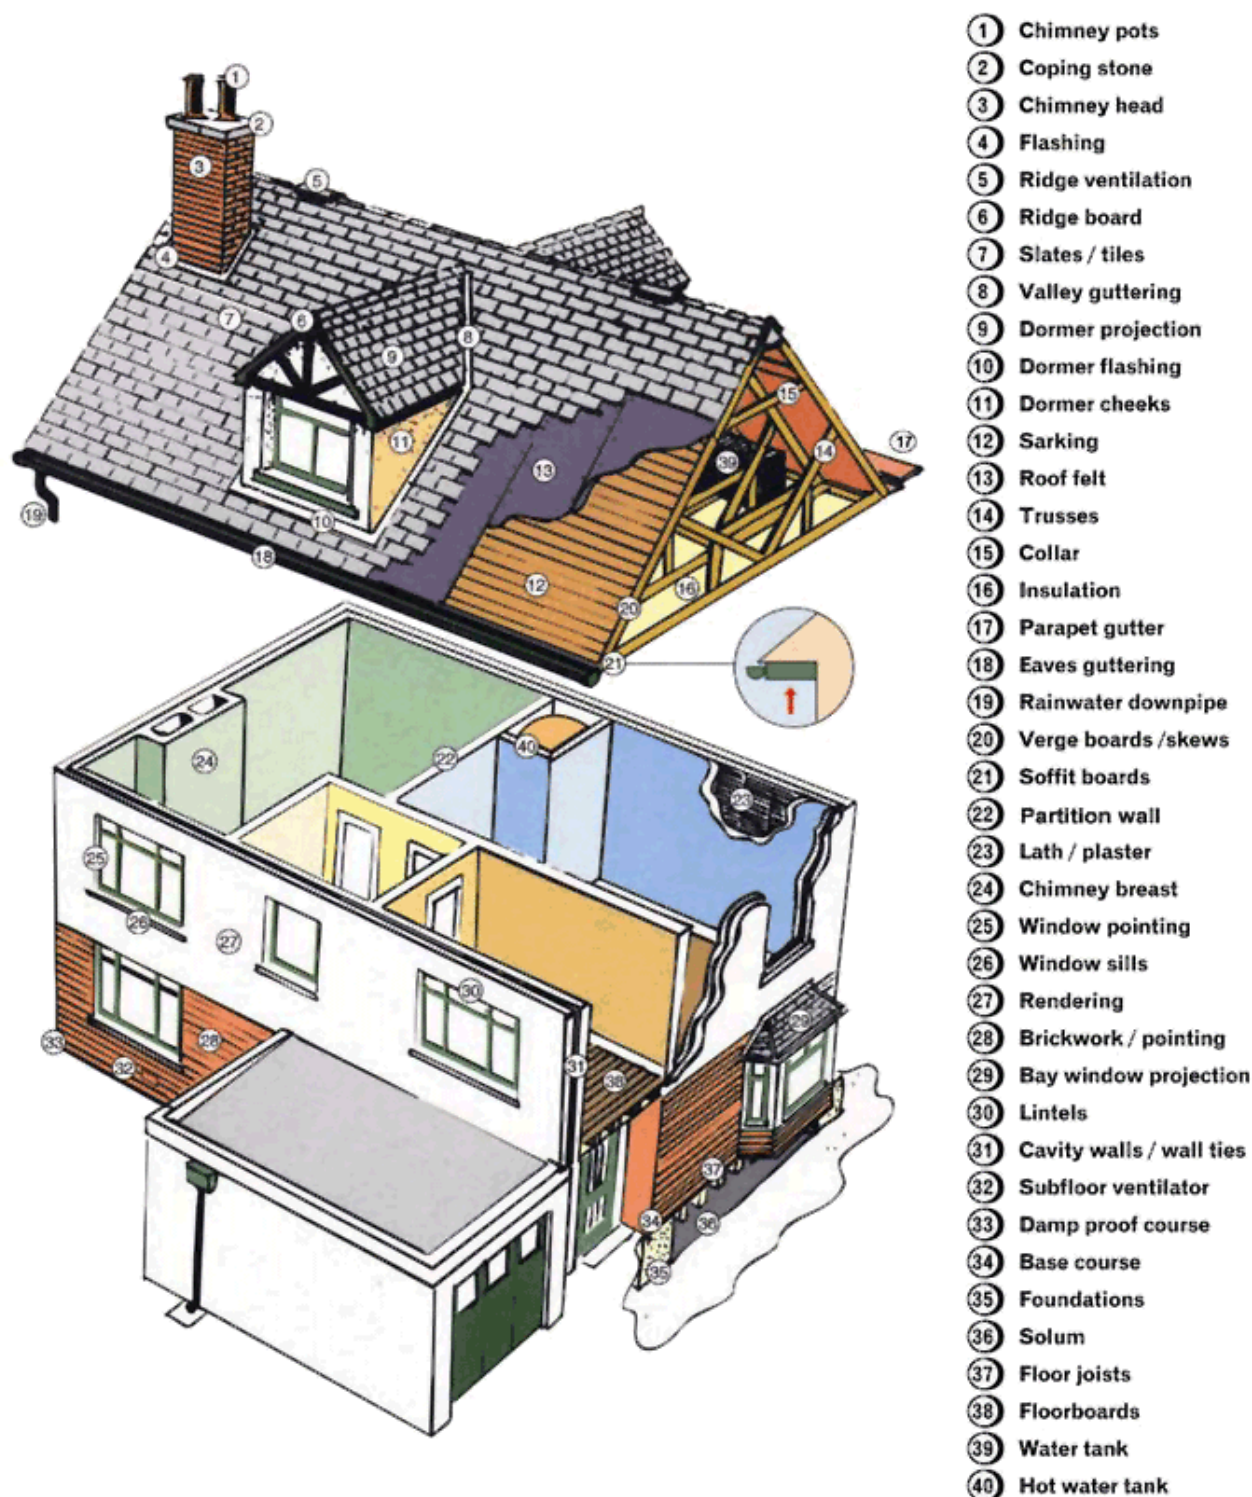
## Sectional Diagram showing elements of a typical house

Reference may be made in this report to some or all of the above component parts of the property. This diagram may assist you in locating and understanding these items.
