HOME REPORT

Property: **22  
Schoolhouse Avenue  
Lanark  
Lanarkshire  
ML11 0LL**

# ENERGY REPORT

# Energy Performance Certificate (EPC)

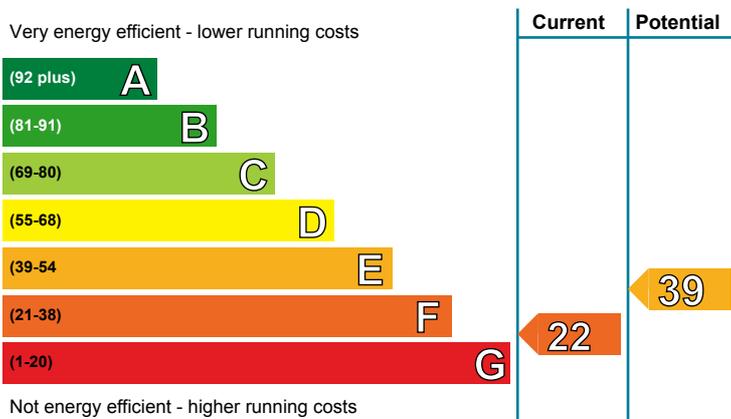
## Energy Efficiency Rating

This graph shows the current efficiency of your home, taking into account both energy efficiency and fuel costs. The higher this rating, the lower your fuel bills are likely to be.

Your current rating is **band F (22)**. The average rating for EPCs in Scotland is **band D (61)**.

The potential rating shows the effect of undertaking all of the improvement measures listed within your recommendations report.

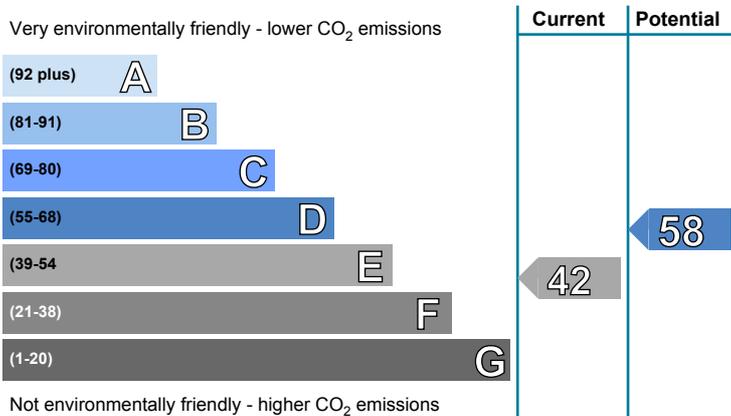
## Environmental Impact (CO<sub>2</sub>) Rating

This graph shows the effect of your home on the environment in terms of carbon dioxide (CO<sub>2</sub>) emissions. The higher the rating, the less impact it has on the environment.

The potential rating shows the effect of undertaking all of the improvement measures listed within your recommendations report.

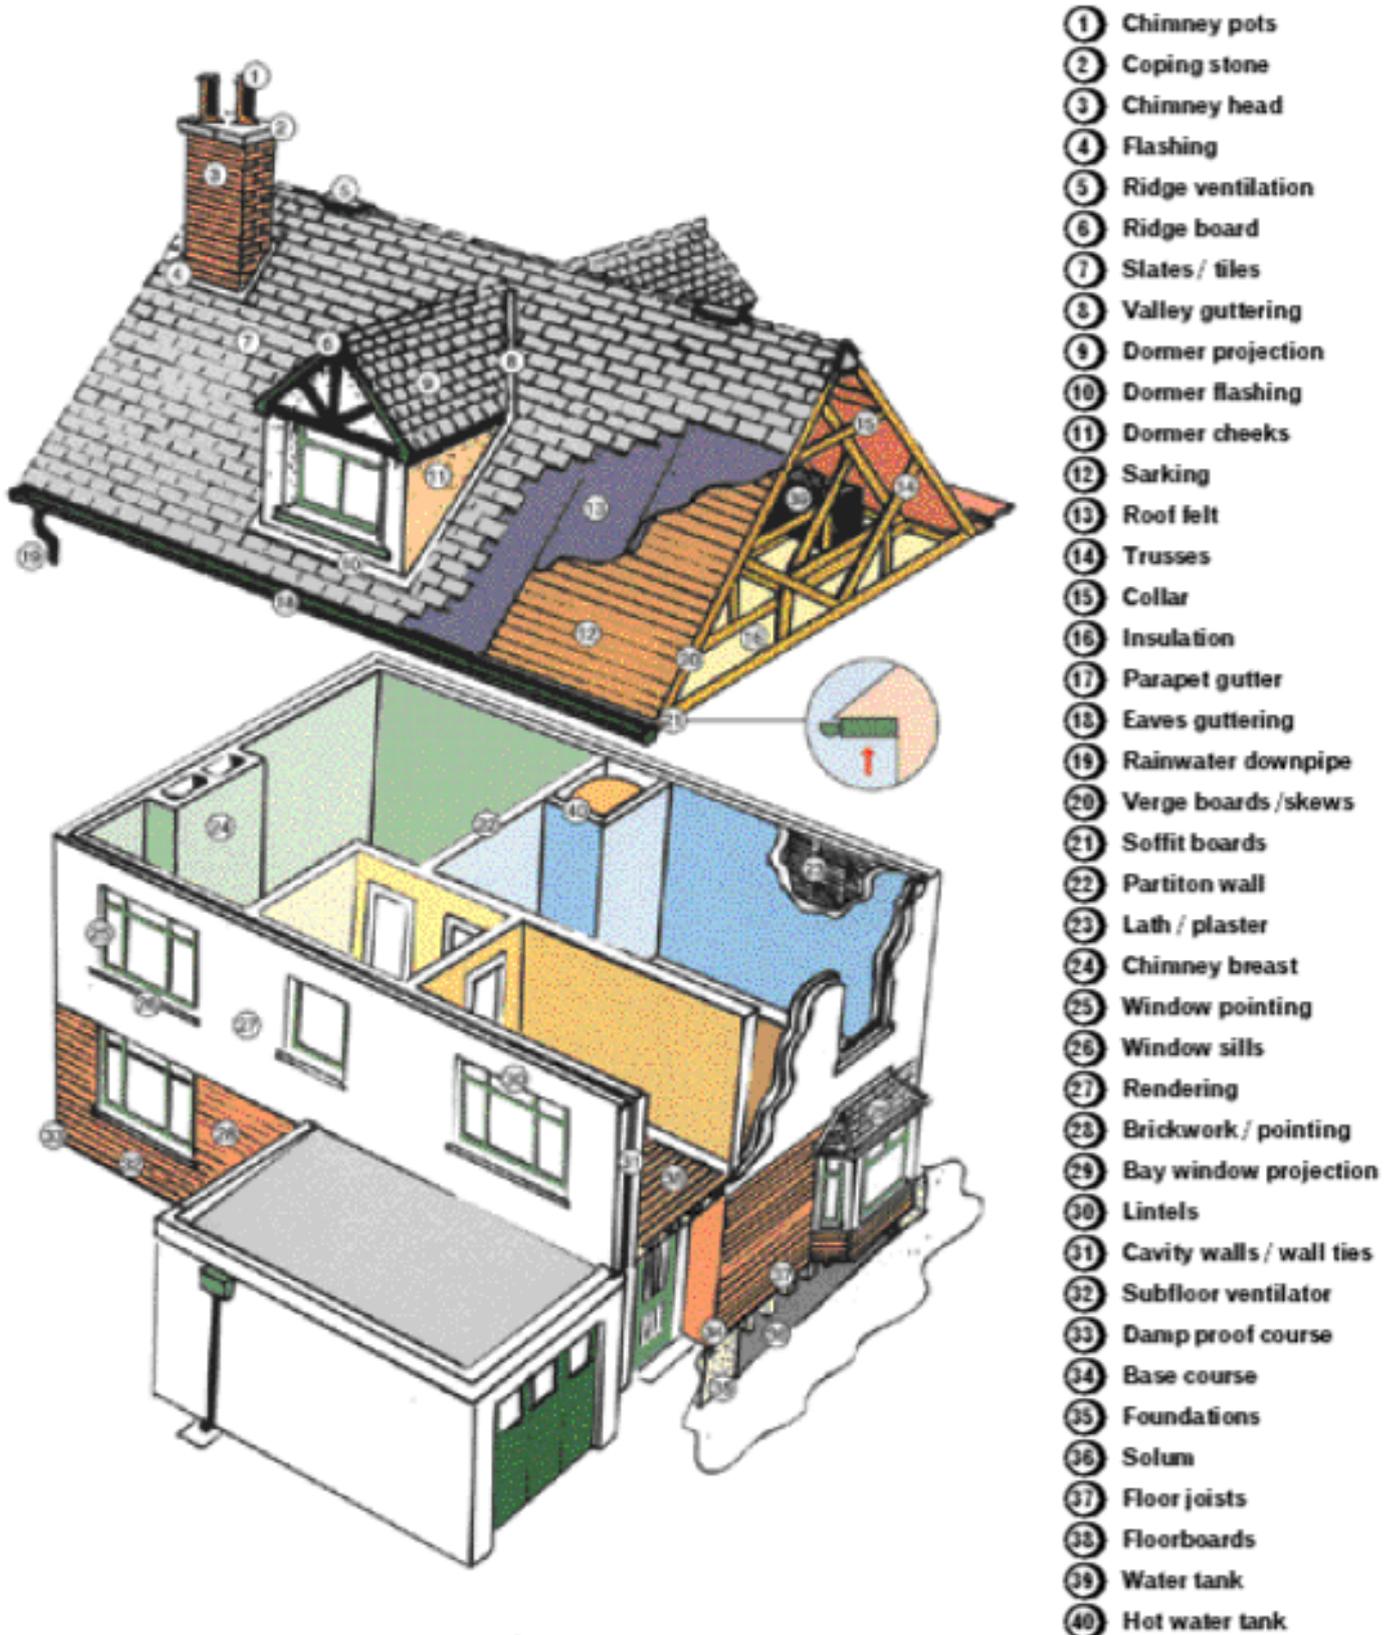
▷ Sectional diagram showing elements of a typical house:

- ① Chimney pots
- ② Coping stone
- ③ Chimney head
- ④ Flashing
- ⑤ Ridge ventilation
- ⑥ Ridge board
- ⑦ Slates / tiles
- ⑧ Valley guttering
- ⑨ Dormer projection
- ⑩ Dormer flashing
- ⑪ Dormer cheeks
- ⑫ Sarking
- ⑬ Roof felt
- ⑭ Trusses
- ⑮ Collar
- ⑯ Insulation
- ⑰ Parapet gutter
- ⑱ Eaves guttering
- ⑲ Rainwater downpipe
- ⑳ Verge boards /skews
- ㉑ Soffit boards
- ㉒ Partiton wall
- ㉓ Lath / plaster
- ㉔ Chimney breast
- ㉕ Window pointing
- ㉖ Window sills
- ㉗ Rendering
- ㉘ Brickwork / pointing
- ㉙ Bay window projection
- ㉚ Lintels
- ㉛ Cavity walls / wall ties
- ㉜ Subfloor ventilator
- ㉝ Damp proof course
- ㉞ Base course
- ㉟ Foundations
- ㊱ Solum
- ㊲ Floor joists
- ㊳ Floorboards
- ㊴ Water tank
- ㊵ Hot water tank

Reference may be made in this report to some or all of the above component parts of the property. This diagram may assist you in locating and understanding these terms.
