# Home Report

28 Dillichip Terrace  
Alexandria  
G83 9HZ

# single survey

## survey report on:

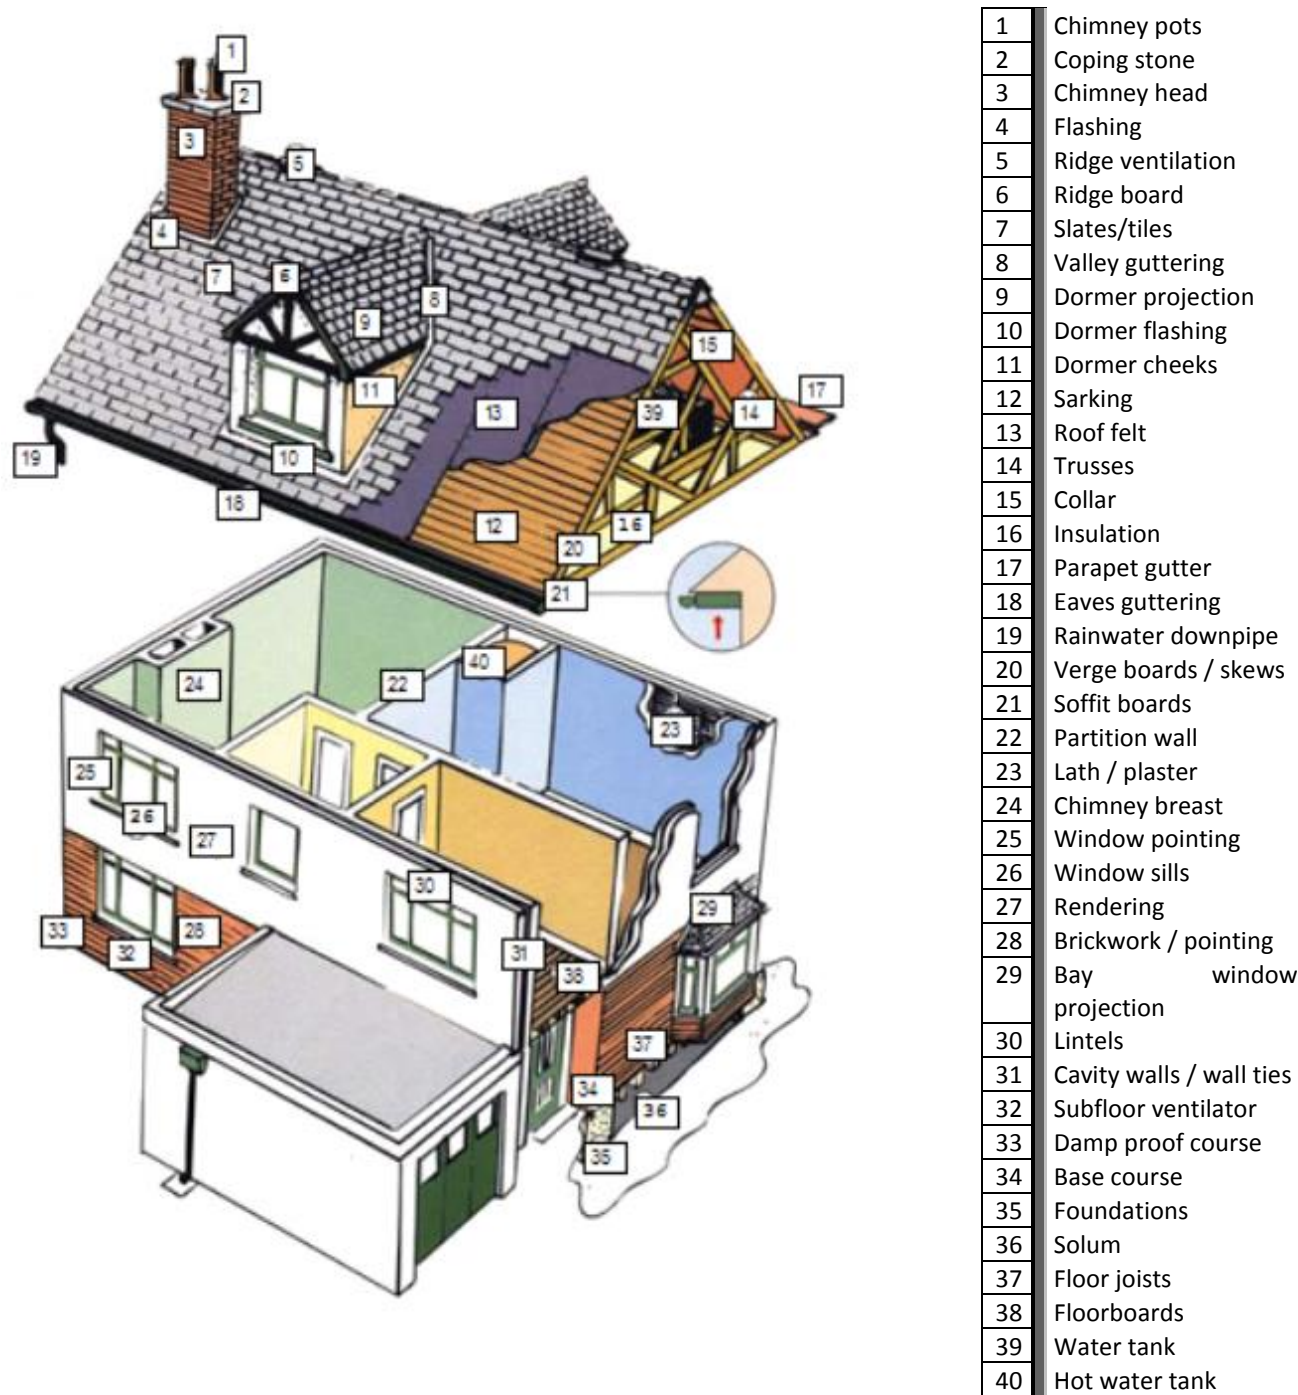
### Sectional Diagram showing elements of a typical house

Reference may be made in this report to some or all of the above component parts of the property. This diagram may assist you in locating and understanding these items.
