# HOME REPORT

120B KING STREET  
ABERDEEN  
AB24 5BB

# Energy Performance Certificate (EPC)

120B KING STREET, ABERDEEN, AB24 5BB

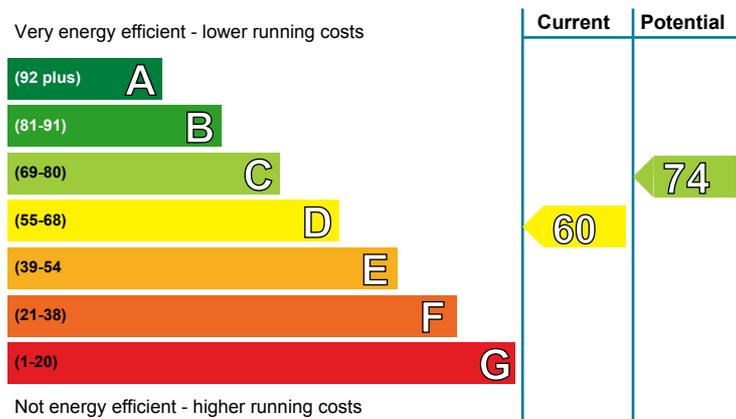
## Energy Efficiency Rating

This graph shows the current efficiency of your home, taking into account both energy efficiency and fuel costs. The higher this rating, the lower your fuel bills are likely to be.

Your current rating is **band D (60)**. The average rating for EPCs in Scotland is **band D (61)**.

The potential rating shows the effect of undertaking all of the improvement measures listed within your recommendations report.

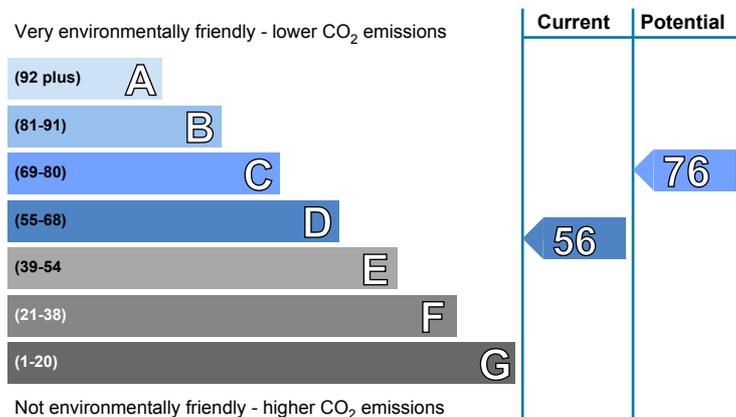
## Environmental Impact (CO<sub>2</sub>) Rating

This graph shows the effect of your home on the environment in terms of carbon dioxide (CO<sub>2</sub>) emissions. The higher the rating, the less impact it has on the environment.

Your current rating is **band D (56)**. The average rating for EPCs in Scotland is **band D (59)**.

The potential rating shows the effect of undertaking all of the improvement measures listed within your recommendations report.
