# Home Report

Property:           **42  
Kirk Street  
Alloa  
Clackmannanshire  
FK10 4PT**

Report reference: **839254-1-2**

Date of Report:     **09/02/2021**

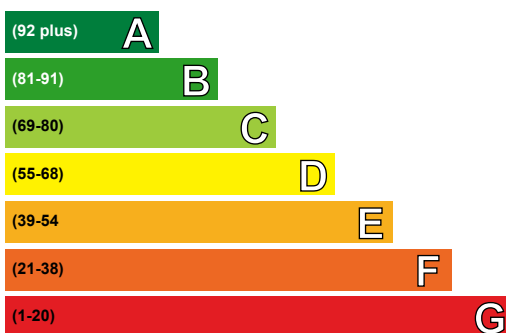
## Energy Efficiency Rating

Very energy efficient - lower running costs

Not energy efficient - higher running costs

| Current | Potential |
| 65 | 78 |

The potential rating shows the effect of undertaking all of the improvement measures listed within your recommendations report.
