# Home Report

Property: **2/2**  
**356 Pollokshaws Road**  
**Glasgow**  
**Lanarkshire**  
**G41 1QS**

Report reference: **840486-1-2**

# Single Survey

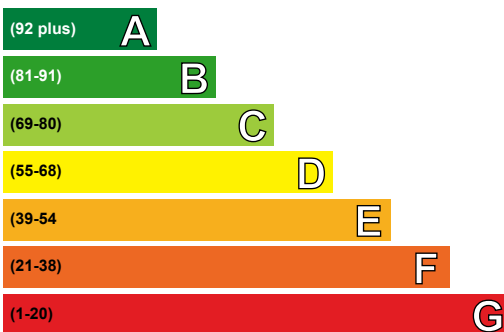
## Energy Efficiency Rating

This graph shows the current efficiency of your home, taking into account both energy efficiency and fuel costs. The higher this rating, the lower your fuel bills are likely to be.

Your current rating is **band B (82)**. The average rating for EPCs in Scotland is **band D (61)**.

The potential rating shows the effect of undertaking all of the improvement measures listed within your recommendations report.
