# Single Survey

survey report on:

| <b>Property address</b> | 23 Mary Elmslie Court<br>Aberdeen<br>AB24 5BE |
| <b>Prepared by</b> | ALLIED SURVEYORS SCOTLAND PLC |

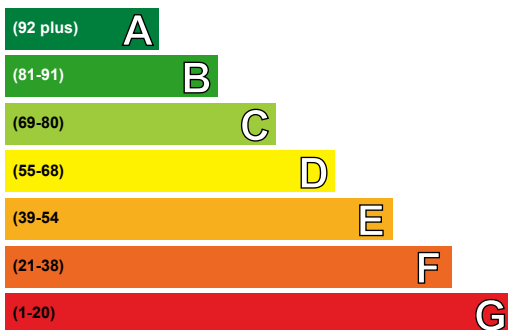
\* based upon the cost of energy for heating, hot water, lighting and ventilation, calculated using standard assumptions

Very energy efficient - lower running costs

Not energy efficient - higher running costs

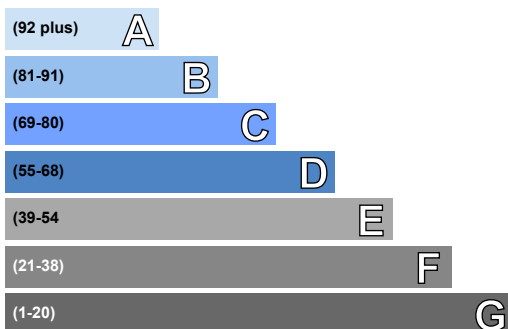
Very environmentally friendly - lower CO<sub>2</sub> emissions

Not environmentally friendly - higher CO<sub>2</sub> emissions
