Home Report

Property: **23d
East High Street
Crieff
Perth And Kinross
PH7 3AF**

Report reference: **858620-1-2**

Date of Report: **20/12/2019**

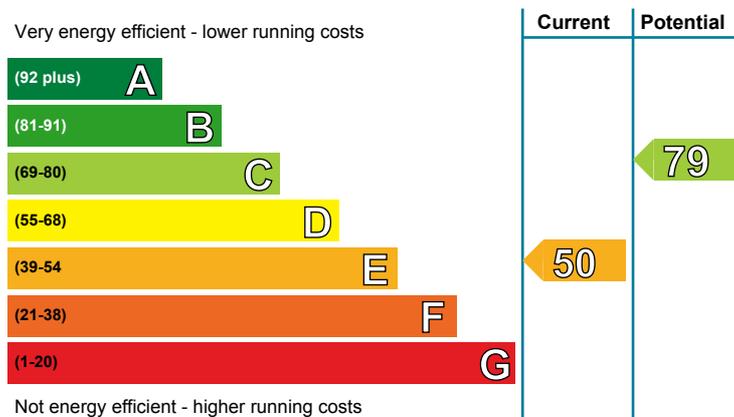
Energy Efficiency Rating

This graph shows the current efficiency of your home, taking into account both energy efficiency and fuel costs. The higher this rating, the lower your fuel bills are likely to be.

Your current rating is **band E (50)**. The average rating for EPCs in Scotland is **band D (61)**.

The potential rating shows the effect of undertaking all of the improvement measures listed within your recommendations report.

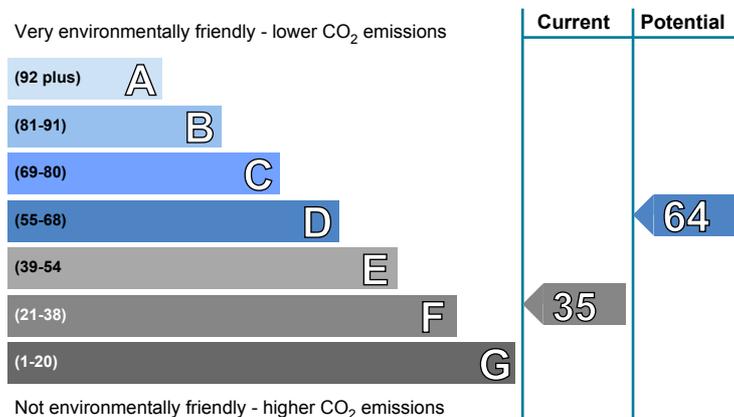
Environmental Impact (CO₂) Rating

This graph shows the effect of your home on the environment in terms of carbon dioxide (CO₂) emissions. The higher the rating, the less impact it has on the environment.

The potential rating shows the effect of undertaking all of the improvement measures listed within your recommendations report.
