# Home Report

Property: **2 Lauchope Lodge  
Well Road  
Moffat  
Dumfries And Galloway  
DG10 9JT**

Report reference: **858941-1-2**

Date of Report: **19/11/2019**

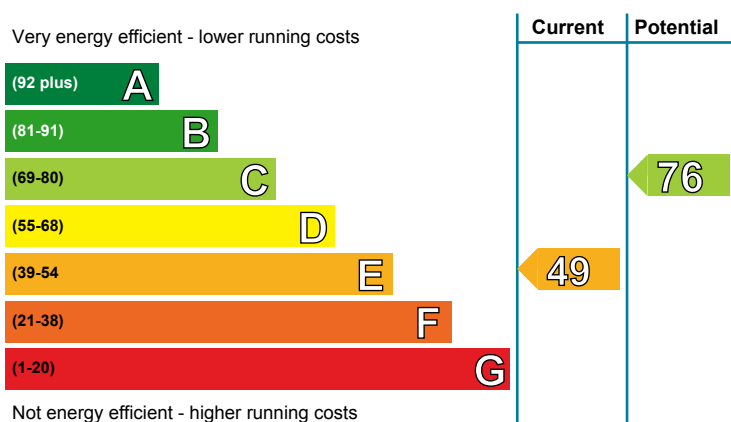
## Energy Efficiency Rating

This graph shows the current efficiency of your home, taking into account both energy efficiency and fuel costs. The higher this rating, the lower your fuel bills are likely to be.

Your current rating is **band E (49)**. The average rating for EPCs in Scotland is **band D (61)**.

The potential rating shows the effect of undertaking all of the improvement measures listed within your recommendations report.

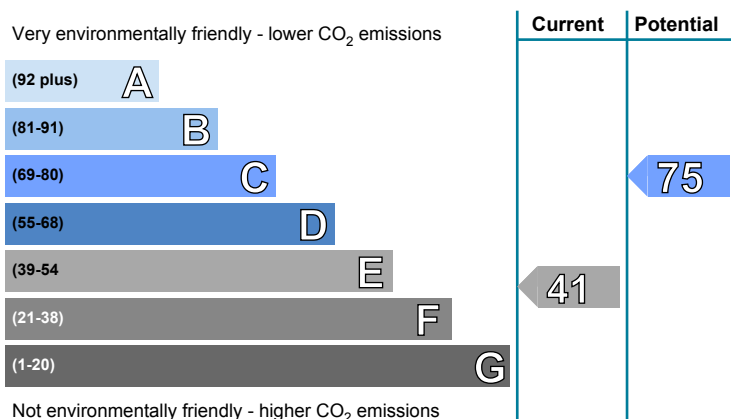
## Environmental Impact (CO<sub>2</sub>) Rating

This graph shows the effect of your home on the environment in terms of carbon dioxide (CO<sub>2</sub>) emissions. The higher the rating, the less impact it has on the environment.

The potential rating shows the effect of undertaking all of the improvement measures listed within your recommendations report.

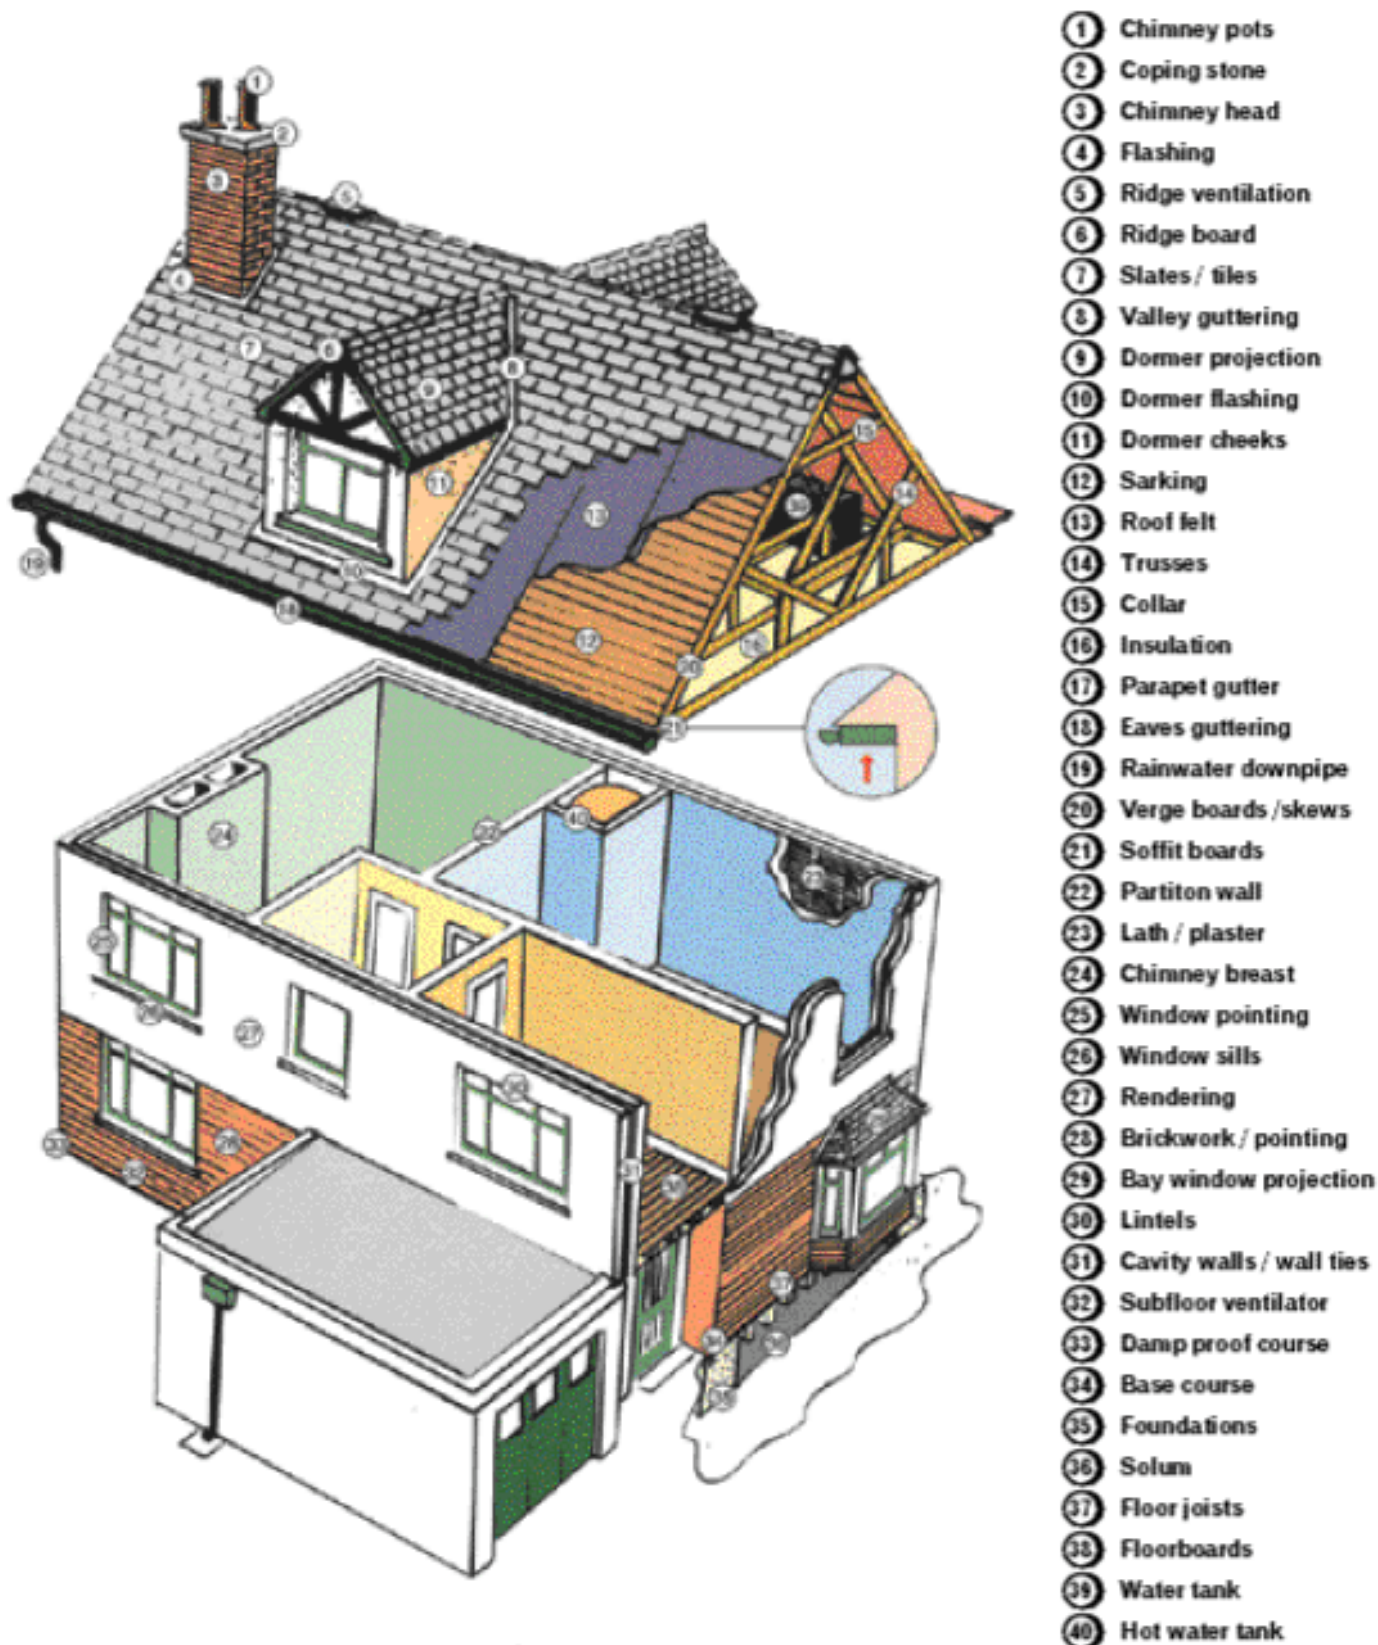
▷ Sectional diagram showing elements of a typical house:

Reference may be made in this report to some or all of the above component parts of the property. This diagram may assist you in locating and understanding these terms.
