# single survey

## survey report on:

| <b>Property address</b> | 14 Murrayfield Place<br><br>Bannockburn<br>FK7 8NE |

| <b>Description</b> | The subjects comprise a Two Storey End Terraced Villa. |

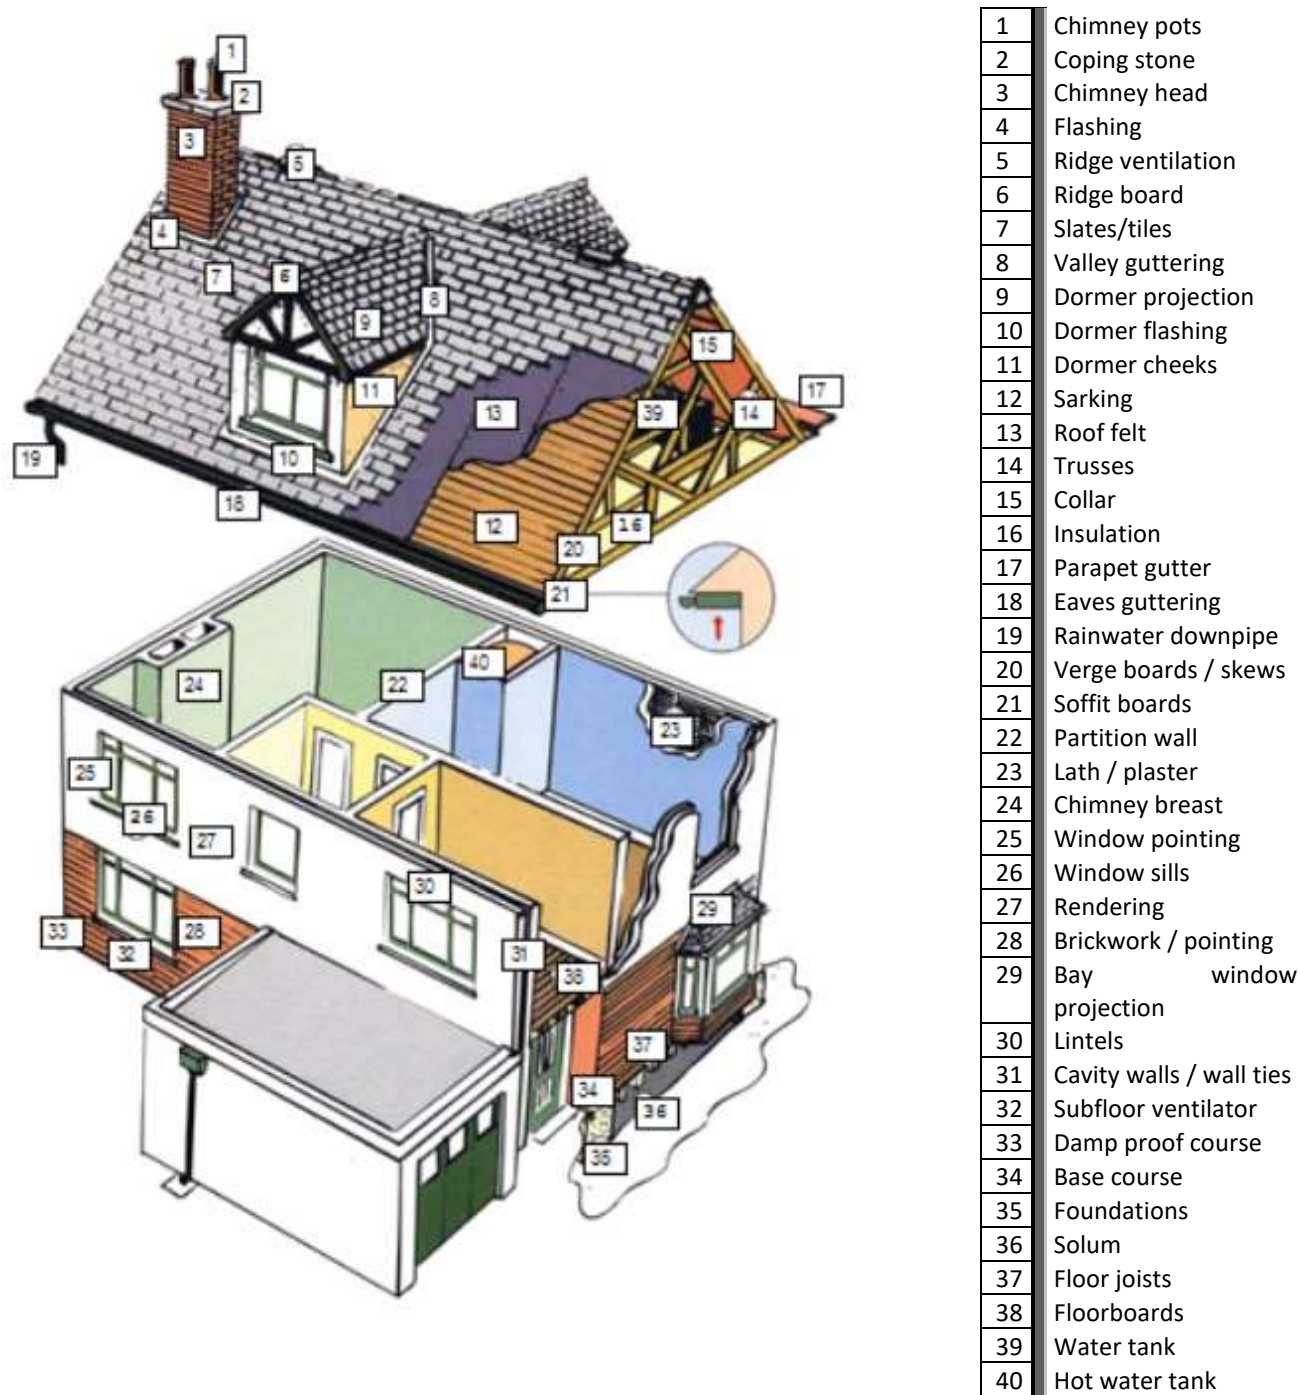
# Sectional Diagram showing elements of a typical house

Reference may be made in this report to some or all of the above component parts of the property. This diagram may assist you in locating and understanding these items.
