## **Home Report**

Property: **108e  
Commercial Street  
Dundee  
Angus  
DD1 2AJ**

Report reference: **886534-1-2**

Date of Report: **06/02/2020**

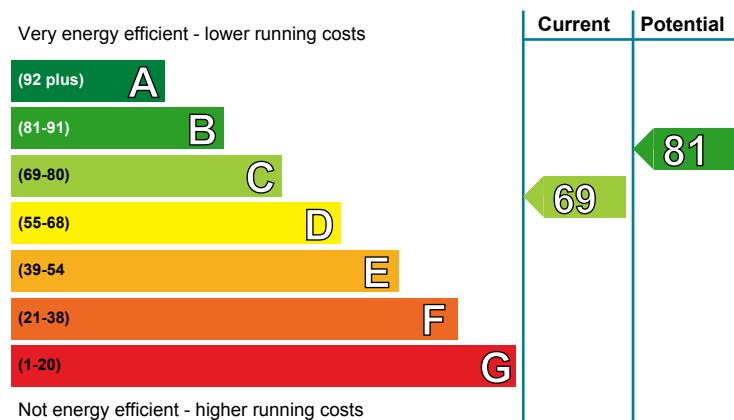
## Energy Efficiency Rating

This graph shows the current efficiency of your home, taking into account both energy efficiency and fuel costs. The higher this rating, the lower your fuel bills are likely to be.

Your current rating is **band C (69)**. The average rating for EPCs in Scotland is **band D (61)**.

The potential rating shows the effect of undertaking all of the improvement measures listed within your recommendations report.

Recommended measures	Indicative cost	Typical saving per year	Rating after improvement	
			Energy	Environment
1 Internal or external wall insulation	£4,000 - £14,000	£289	C 78	D 68
2 Add additional 80 mm jacket to hot water cylinder	£15 - £30	£14	C 79	D 68
3 High heat retention storage heaters	£1,200 - £1,800	£74	B 81	C 71

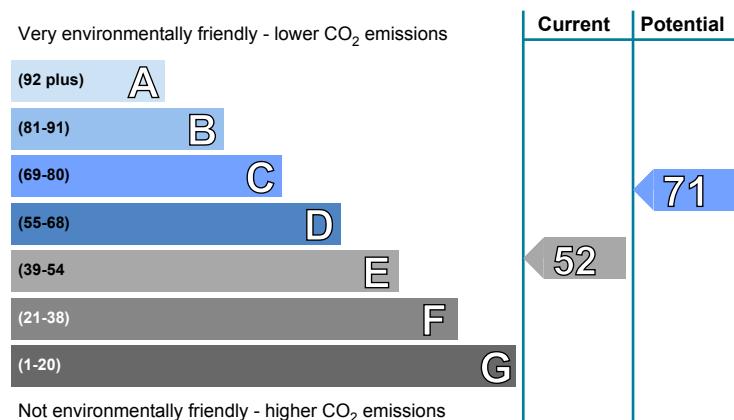
## Environmental Impact (CO<sub>2</sub>) Rating

This graph shows the effect of your home on the environment in terms of carbon dioxide (CO<sub>2</sub>) emissions. The higher the rating, the less impact it has on the environment.

The potential rating shows the effect of undertaking all of the improvement measures listed within your recommendations report.

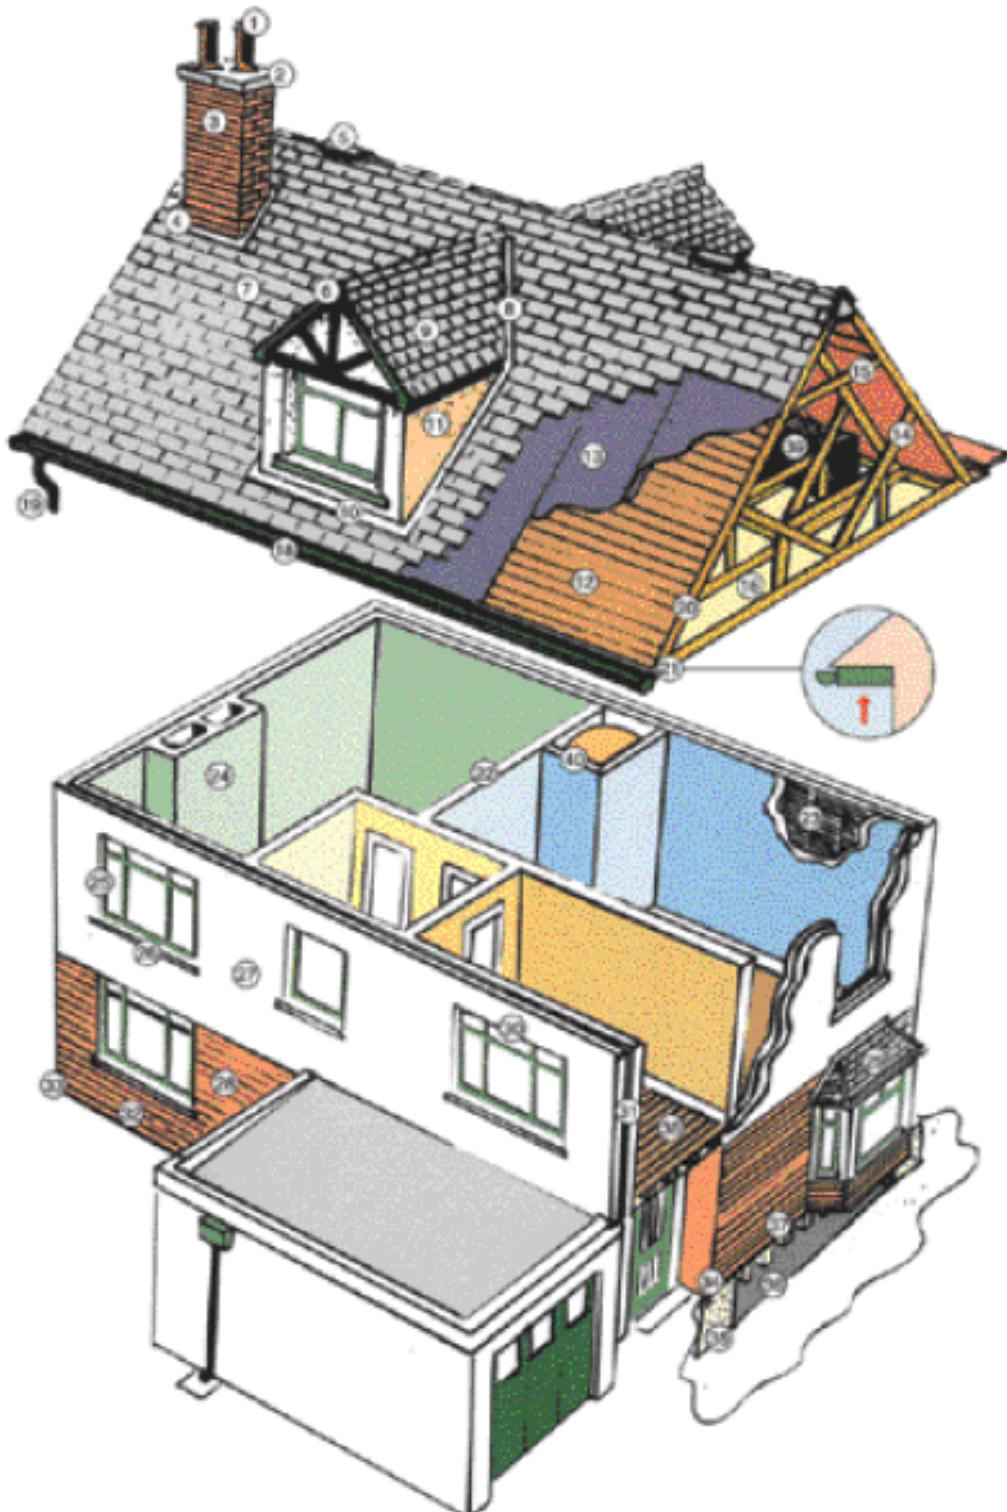
► Sectional diagram showing elements of a typical house:

- 1 Chimney pots
- 2 Coping stone
- 3 Chimney head
- 4 Flashing
- 5 Ridge ventilation
- 6 Ridge board
- 7 Slates / tiles
- 8 Valley guttering
- 9 Dormer projection
- 10 Dormer flashing
- 11 Dormer cheeks
- 12 Sarking
- 13 Roof felt
- 14 Trusses
- 15 Collar
- 16 Insulation
- 17 Parapet gutter
- 18 Eaves guttering
- 19 Rainwater downpipe
- 20 Verge boards /skews
- 21 Soffit boards
- 22 Partition wall
- 23 Lath / plaster
- 24 Chimney breast
- 25 Window pointing
- 26 Window sills
- 27 Rendering
- 28 Brickwork / pointing
- 29 Bay window projection
- 30 Lintels
- 31 Cavity walls / wall ties
- 32 Subfloor ventilator
- 33 Damp proof course
- 34 Base course
- 35 Foundations
- 36 Solum
- 37 Floor joists
- 38 Floorboards
- 39 Water tank
- 40 Hot water tank

Reference may be made in this report to some or all of the above component parts of the property. This diagram may assist you in locating and understanding these terms.
