Home Report

33 St Swithin Street
Aberdeen
AB10 6XL

single survey

Property address	33 St Swithin Street Aberdeen AB10 6XL
Customer	Jane Mackie
Prepared by	Graham + Sibbald Chartered Surveyors

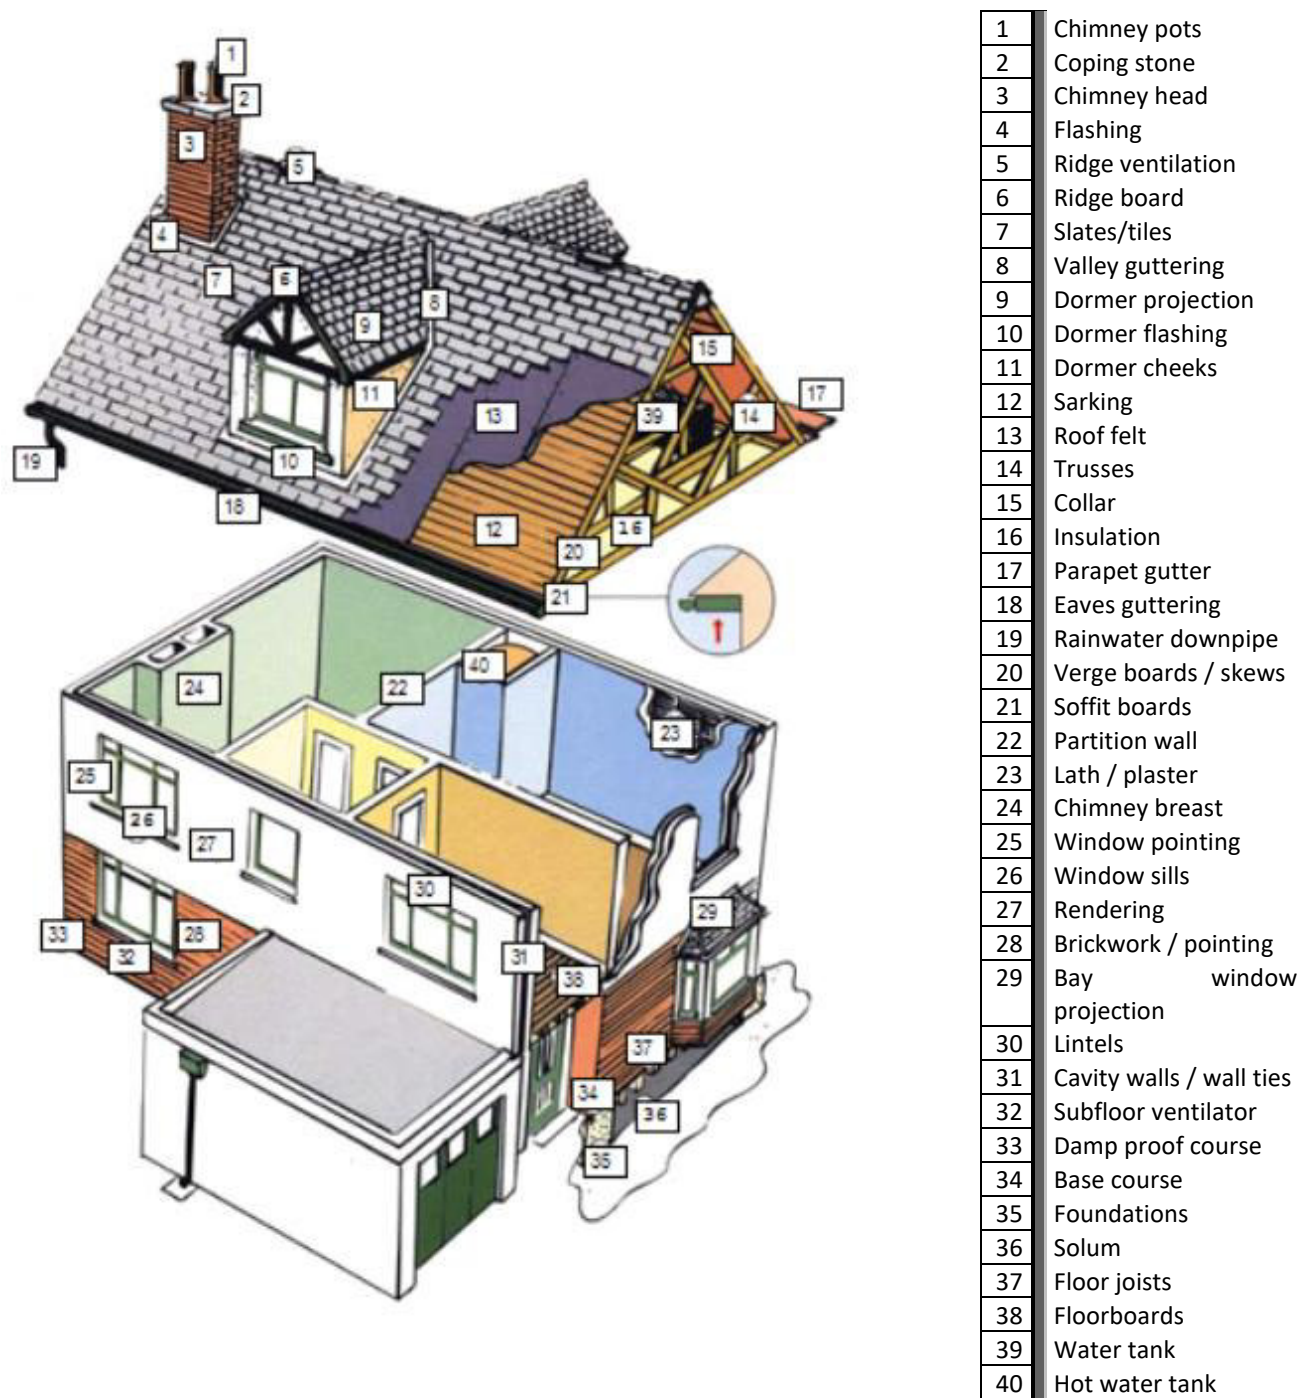
Sectional Diagram showing elements of a typical house

Reference may be made in this report to some or all of the above component parts of the property. This diagram may assist you in locating and understanding these items.
