# Home Report

Property: **Cran Tara  
High Street  
Grantown-on-spey  
Highland  
PH26 3EN**

Prepared by: **Calum Riach MRICS**

Date of Report: **01/07/2020**

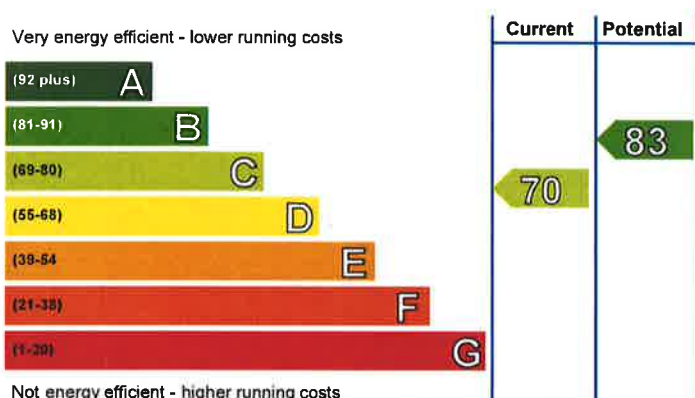
## Energy Efficiency Rating

This graph shows the current efficiency of your home, taking into account both energy efficiency and fuel costs. The higher this rating, the lower your fuel bills are likely to be.

Your current rating is **band C (70)**. The average rating for EPCs in Scotland is **band D (61)**.

The potential rating shows the effect of undertaking all of the improvement measures listed within your recommendations report.

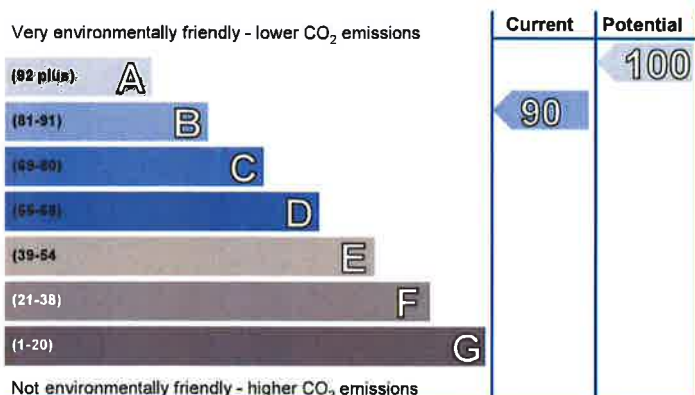
## Environmental Impact (CO<sub>2</sub>) Rating

This graph shows the effect of your home on the environment in terms of carbon dioxide (CO<sub>2</sub>) emissions. The higher the rating, the less impact it has on the environment.

The potential rating shows the effect of undertaking all of the improvement measures listed within your recommendations report.

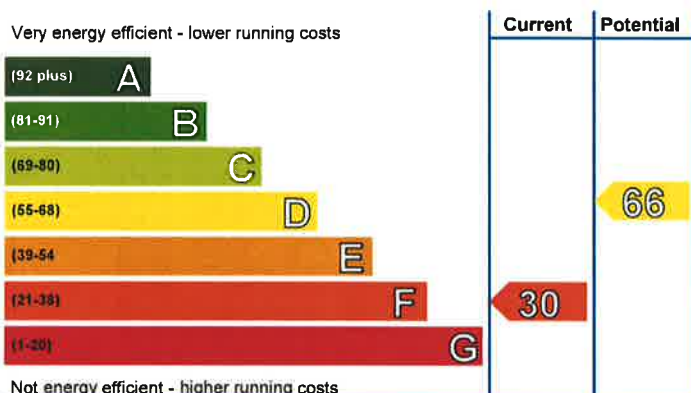
## Energy Efficiency Rating

This graph shows the current efficiency of your home, taking into account both energy efficiency and fuel costs. The higher this rating, the lower your fuel bills are likely to be.

Your current rating is **band F (30)**. The average rating for EPCs in Scotland is **band D (61)**.

The potential rating shows the effect of undertaking all of the improvement measures listed within your recommendations report.

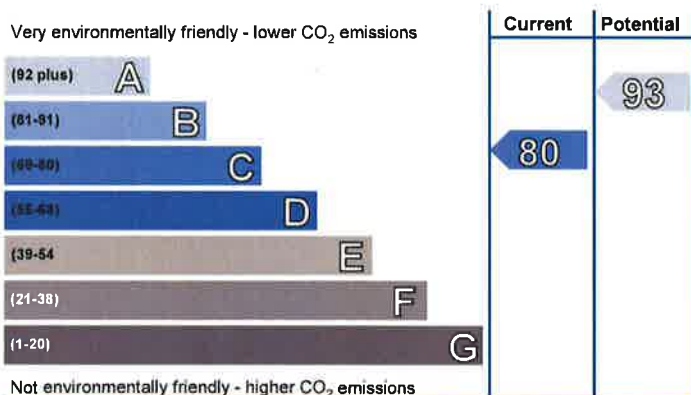
## Environmental Impact (CO<sub>2</sub>) Rating

This graph shows the effect of your home on the environment in terms of carbon dioxide (CO<sub>2</sub>) emissions. The higher the rating, the less impact it has on the environment.
