# Home Report

15 Westhill Crescent  
Westhill  
AB32 6AA

Date of Valuation: 24/06/2020  
AIMS Ref: ABD-2020\06\0067

# single survey

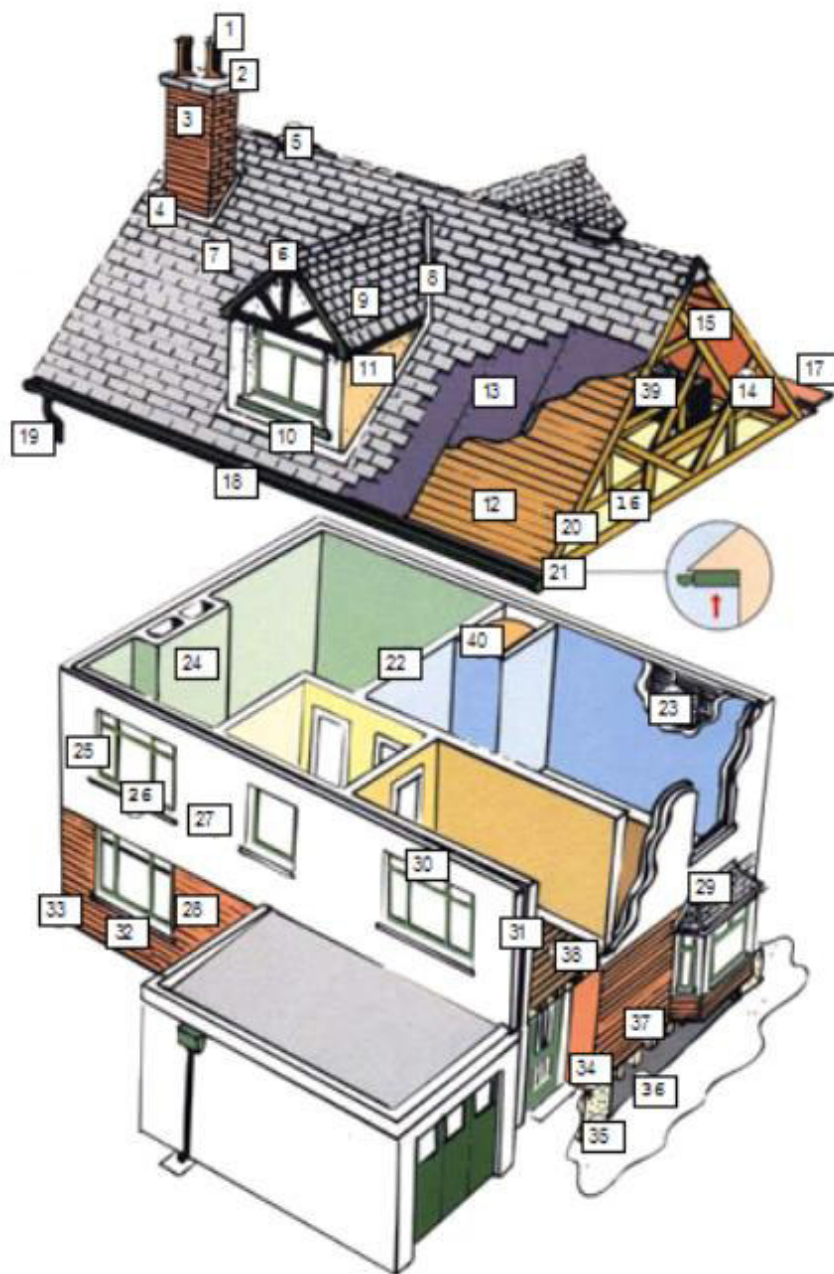
## Sectional Diagram showing elements of a typical house

| 1 | Chimney pots |
| 2 | Coping stone |
| 35 | Foundations |
