## Home Report

Property:           **3**  
                          **Main road**  
                          **Gatehead kilmarnock**  
                          **Ayrshire**  
                          **KA2 0AN**

3 MAIN ROAD, GATEHEAD, KILMARNOCK, KA2 0AN

**Scottish Single Survey**

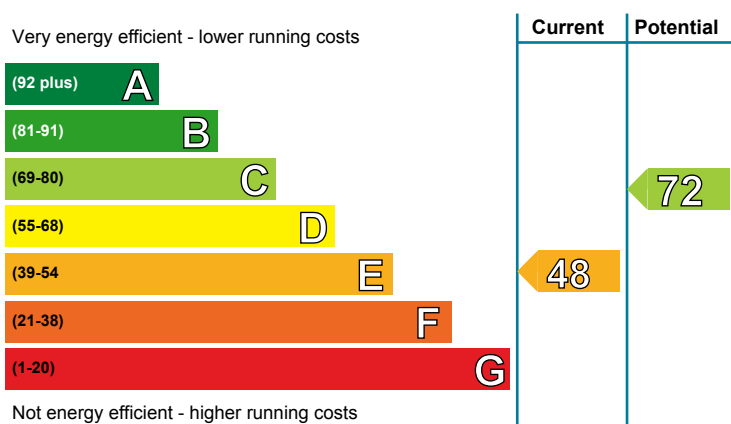
## Energy Efficiency Rating

This graph shows the current efficiency of your home, taking into account both energy efficiency and fuel costs. The higher this rating, the lower your fuel bills are likely to be.

Your current rating is **band E (48)**. The average rating for EPCs in Scotland is **band D (61)**.

The potential rating shows the effect of undertaking all of the improvement measures listed within your recommendations report.

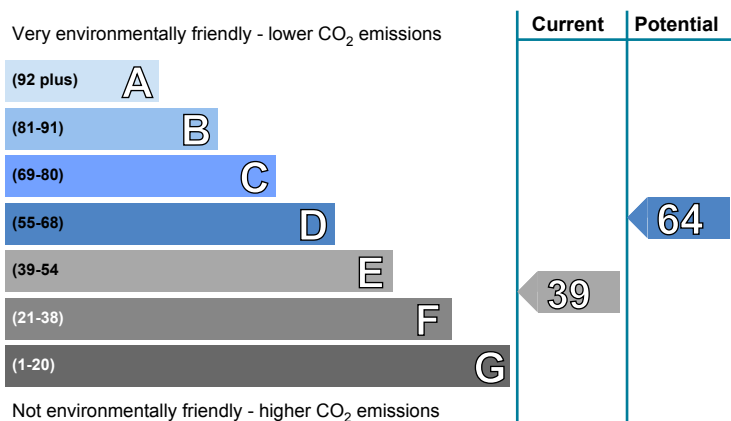
## Environmental Impact (CO<sub>2</sub>) Rating

This graph shows the effect of your home on the environment in terms of carbon dioxide (CO<sub>2</sub>) emissions. The higher the rating, the less impact it has on the environment.

The potential rating shows the effect of undertaking all of the improvement measures listed within your recommendations report.
