Home Report

Property: **4i
Peebles Road
Penicuik
Midlothian
EH26 8LU**

Report reference: **993226-1-2**

Date of Report: **11/08/2020**

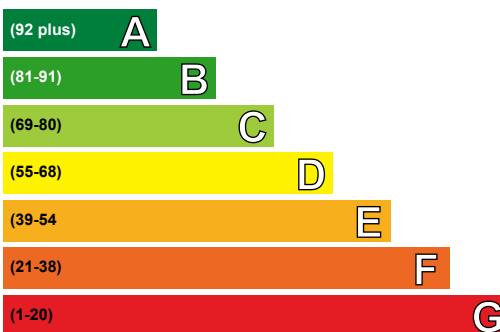
Energy Efficiency Rating

This graph shows the current efficiency of your home, taking into account both energy efficiency and fuel costs. The higher this rating, the lower your fuel bills are likely to be.

Your current rating is **band C (79)**. The average rating for EPCs in Scotland is **band D (61)**.

The potential rating shows the effect of undertaking all of the improvement measures listed within your recommendations report.

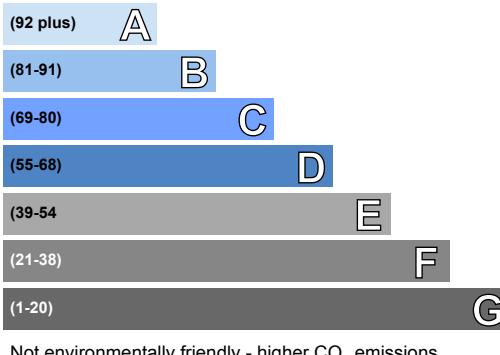
Environmental Impact (CO₂) Rating

The potential rating shows the effect of undertaking all of the improvement measures listed within your recommendations report.

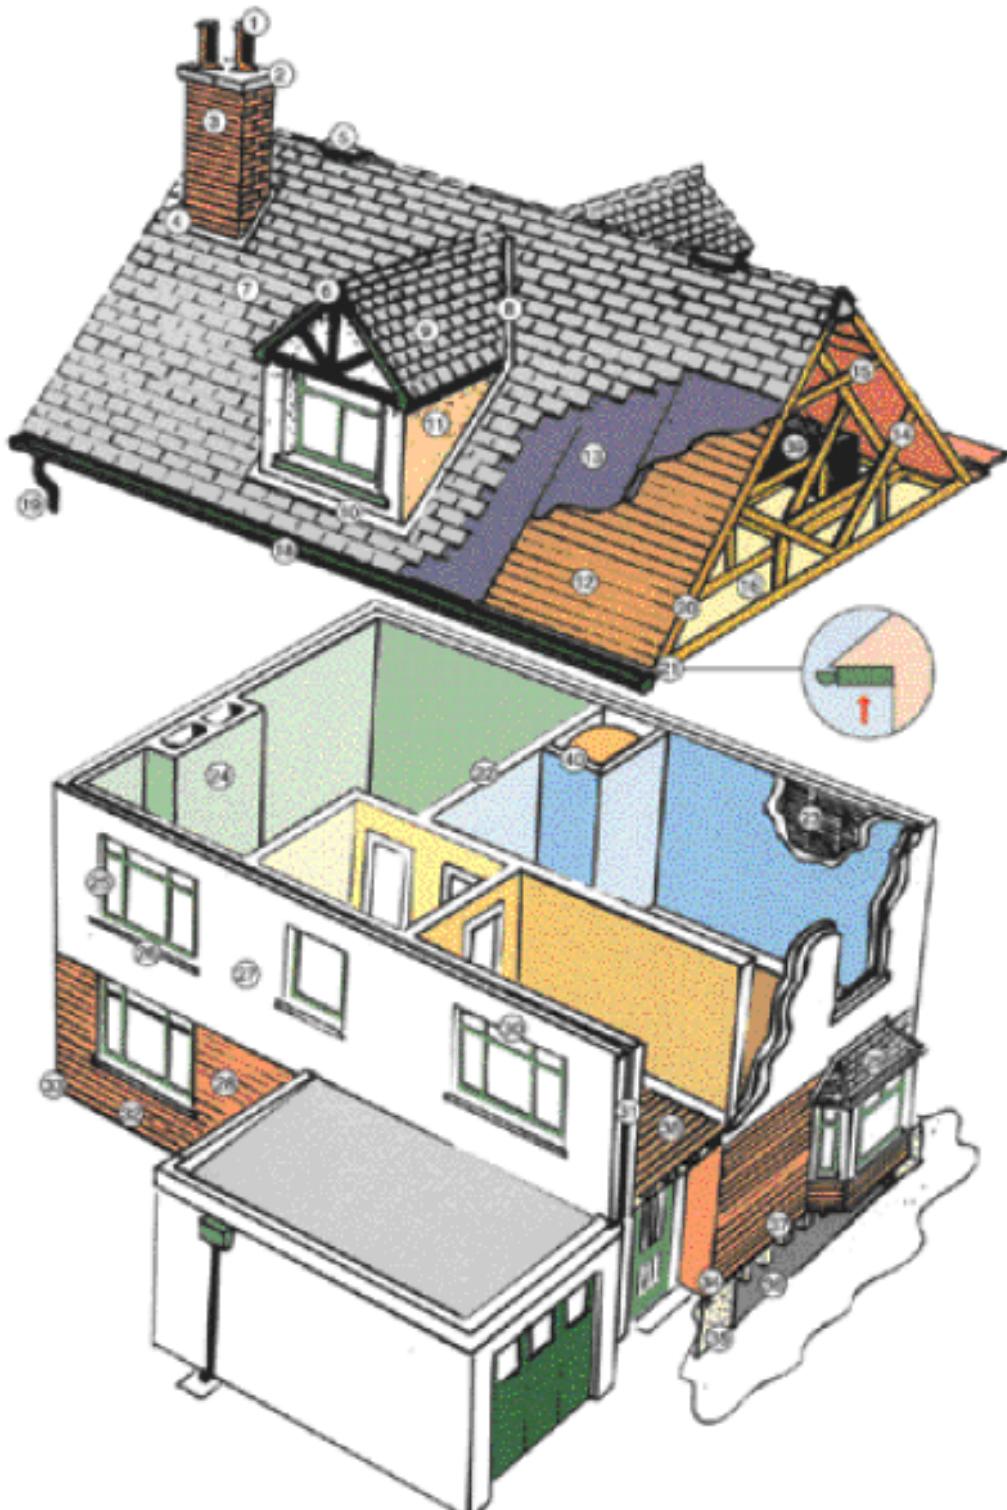
► Sectional diagram showing elements of a typical house:

- 1 Chimney pots
- 2 Coping stone
- 3 Chimney head
- 4 Flashing
- 5 Ridge ventilation
- 6 Ridge board
- 7 Slates / tiles
- 8 Valley guttering
- 9 Dormer projection
- 10 Dormer flashing
- 11 Dormer cheeks
- 12 Sarking
- 13 Roof felt
- 14 Trusses
- 15 Collar
- 16 Insulation
- 17 Parapet gutter
- 18 Eaves guttering
- 19 Rainwater downpipe
- 20 Verge boards /skews
- 21 Soffit boards
- 22 Partition wall
- 23 Lath / plaster
- 24 Chimney breast
- 25 Window pointing
- 26 Window sills
- 27 Rendering
- 28 Brickwork / pointing
- 29 Bay window projection
- 30 Lintels
- 31 Cavity walls / wall ties
- 32 Subfloor ventilator
- 33 Damp proof course
- 34 Base course
- 35 Foundations
- 36 Solum
- 37 Floor joists
- 38 Floorboards
- 39 Water tank
- 40 Hot water tank

Reference may be made in this report to some or all of the above component parts of the property. This diagram may assist you in locating and understanding these terms.
